PLASTIC PIPING DATA COLLECTION INITIATIVE STATUS REPORT

October 2022

Plastic Piping Data Collection Initiative

Status Report

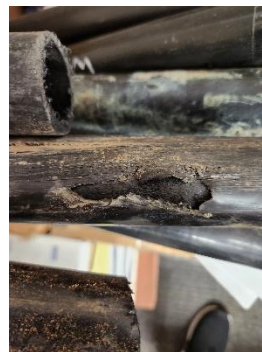
Figures 4 & 5 show external degradation is a peeling effect of the pipe.

Response from PPDC: A review of current PPDC data does not correspond with internal degradation processes. The PPDC will continue monitoring data for potential Drisco 8000 internal pipe wall issues with cracking and brittleness and external degradation of peeling of the pipe.
