PLASTIC PIPING DATA COLLECTION INITIATIVE STATUS REPORT

February 2023

Administered by
American Gas Association
400 North Capitol Street, N.W., 4th Floor
Washington, DC 20001
U.S.A.

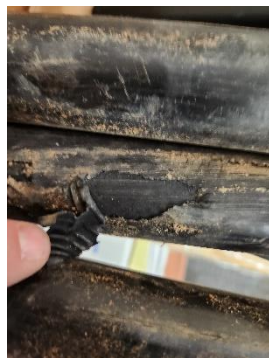
Figure 4

Figures 4 & 5 show external degradation is a peeling effect of the pipe.
