# **PLASTIC PIPING DATA COLLECTION INITIATIVE STATUS REPORT**

November 2023

# Plastic Piping Data Collection Initiative

## Status Report

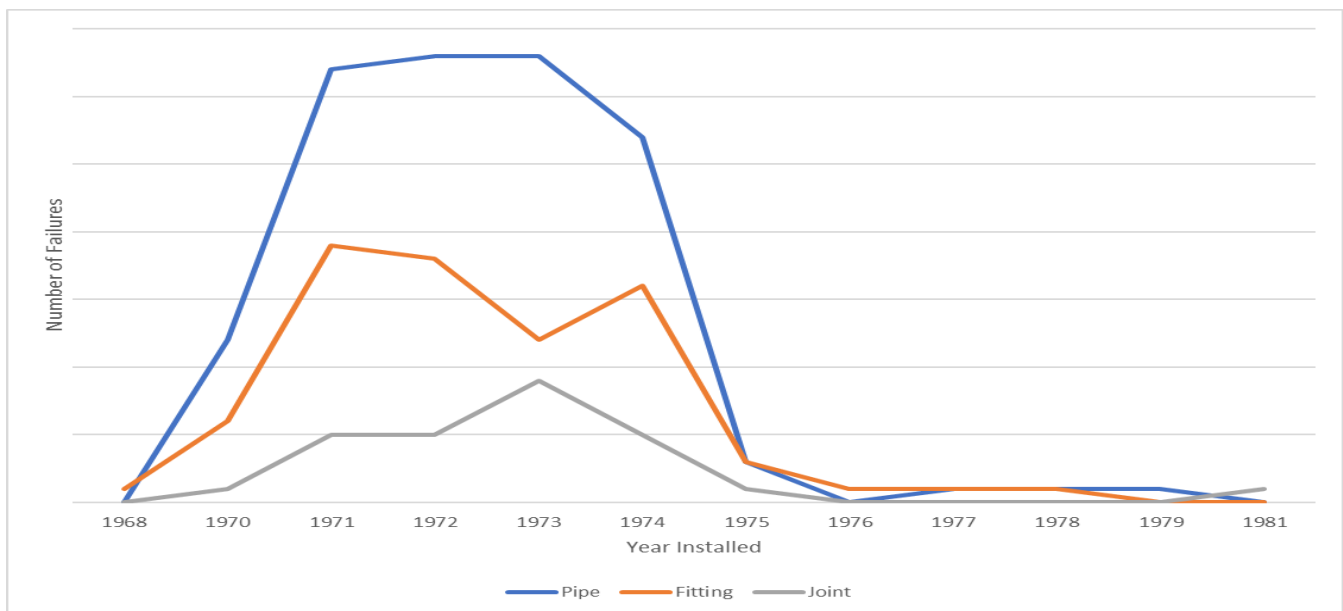
**Figure 1. Failures by Years Installed as Reported to PPDC for Century Pipe, Fittings and Joints**

Century represent less than 1% of all the reports in the database. The majority of the reported Century failures occur on pipe (56%). Other categories include fittings (32%), joints (11%) and unknown (1%). The distribution of failures for pipe, fittings and joints by year installed is shown in Figure 1. The figure shows the majority of failures occurred on pipe installed from 1970 to 1974.

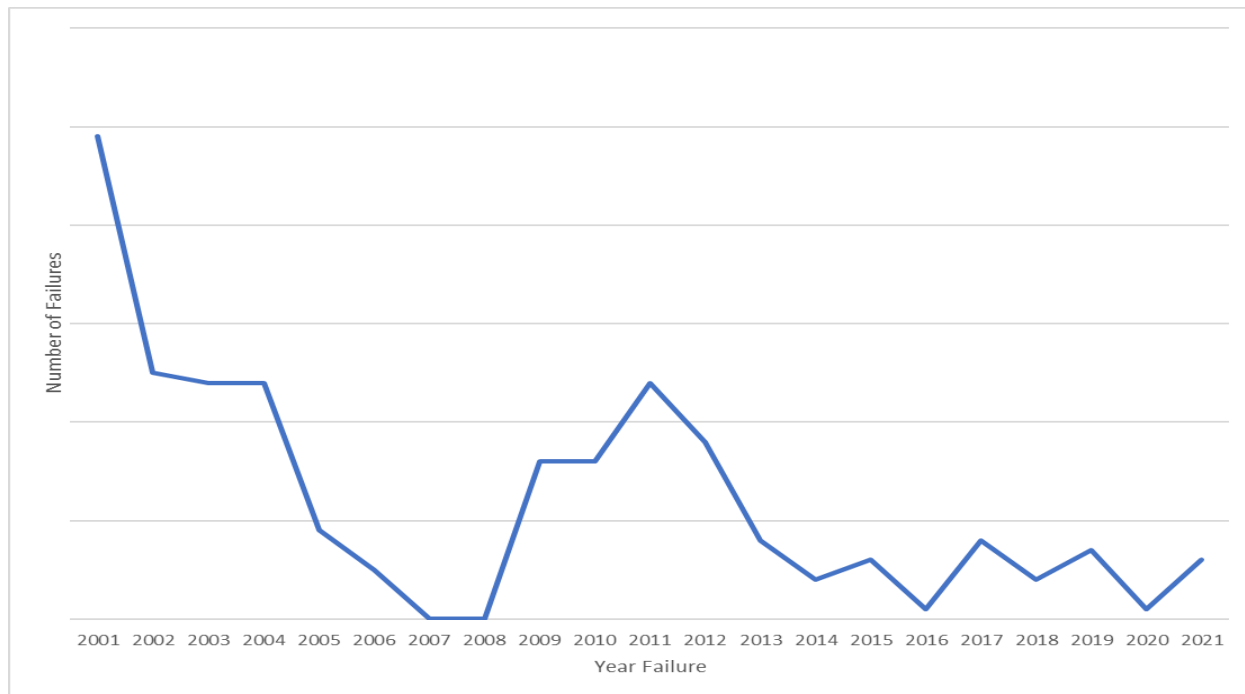
**Figure 2. Failures by Year of Failure as Reported to PPDC for Century**

Figure 2 shows the failures by year of failure. The majority of the failures occurred prior to 2007; however, recently there have been additional reports submitted.

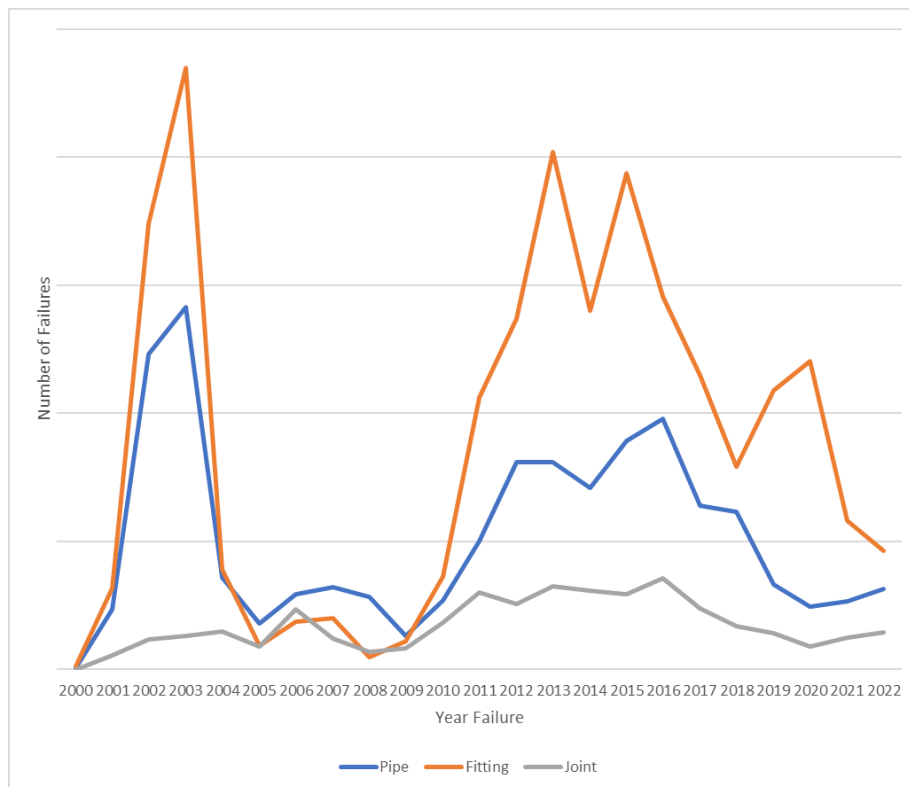
**Figure 1. Failures by Year of Failure as reported to PPDC for Aldyl.**

DuPont and Uponor represent approximately 24% of all the reports in the database. Figure 1 shows the failures by year of failure. As reflected in the graph, there has been a recent increase in data submitted to the database. The majority of the reported Aldyl failures occur on fittings (56%). Other categories include pipe (32%), joints (11%) and unknown (1%).

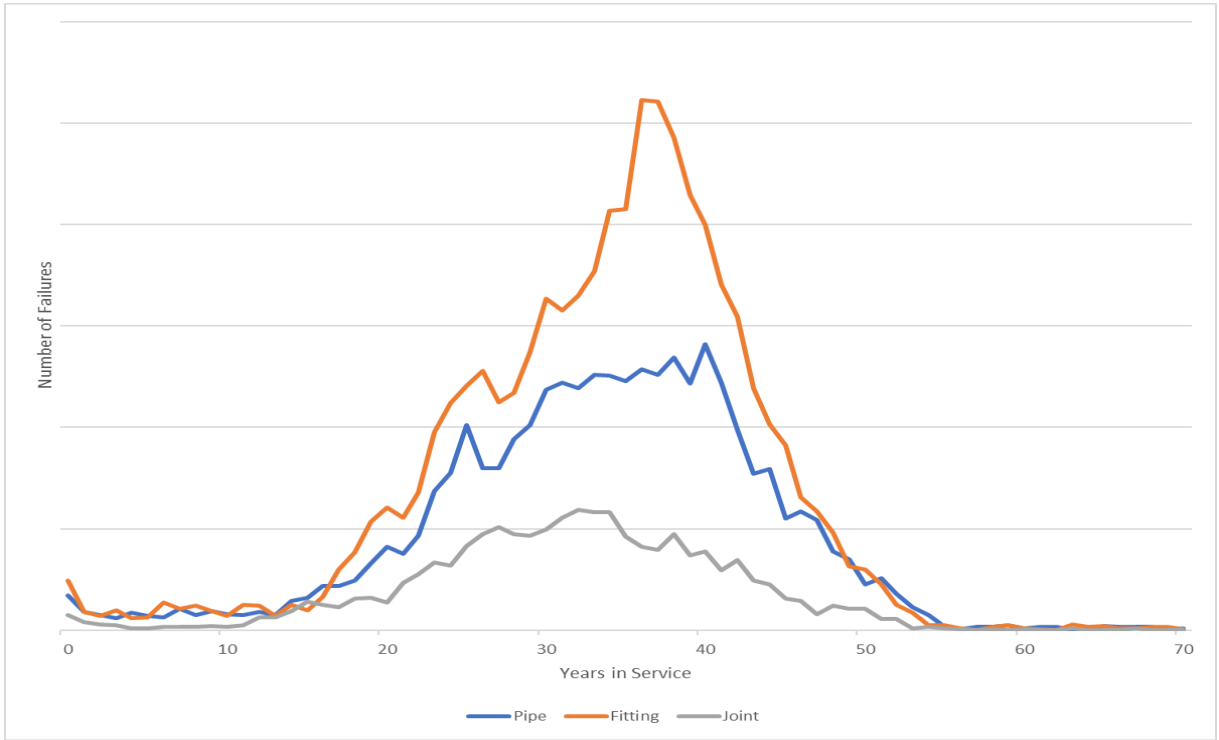
**Figure 2. Failures by Years in Service as reported to PPDC for Aldyl pipe, fittings and joints**

The distribution of the Years in Service of failures is similar for pipe, fittings and joints (Figure 2).

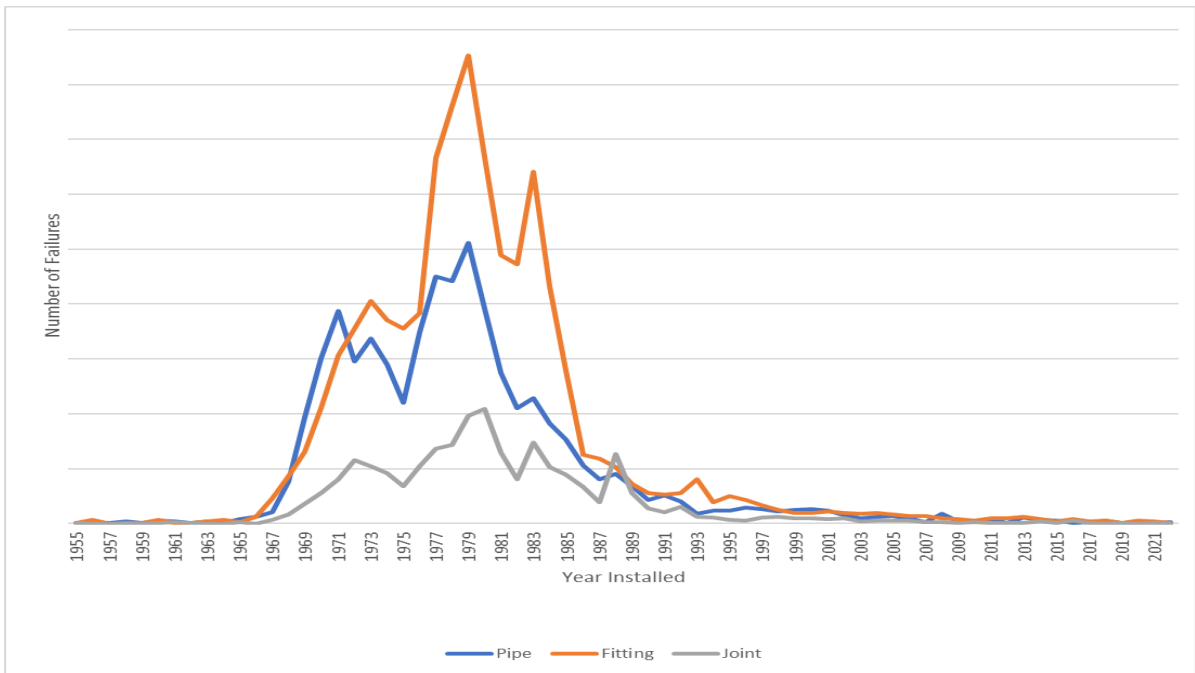
**Figure 3. Failures by Year Installed as reported to PPDC for Aldyl pipe, fittings and joints**

Figure 3 shows the failures by Year Installed. Although Figure 1 shows three data peaks, the year of installation range appears consistent.

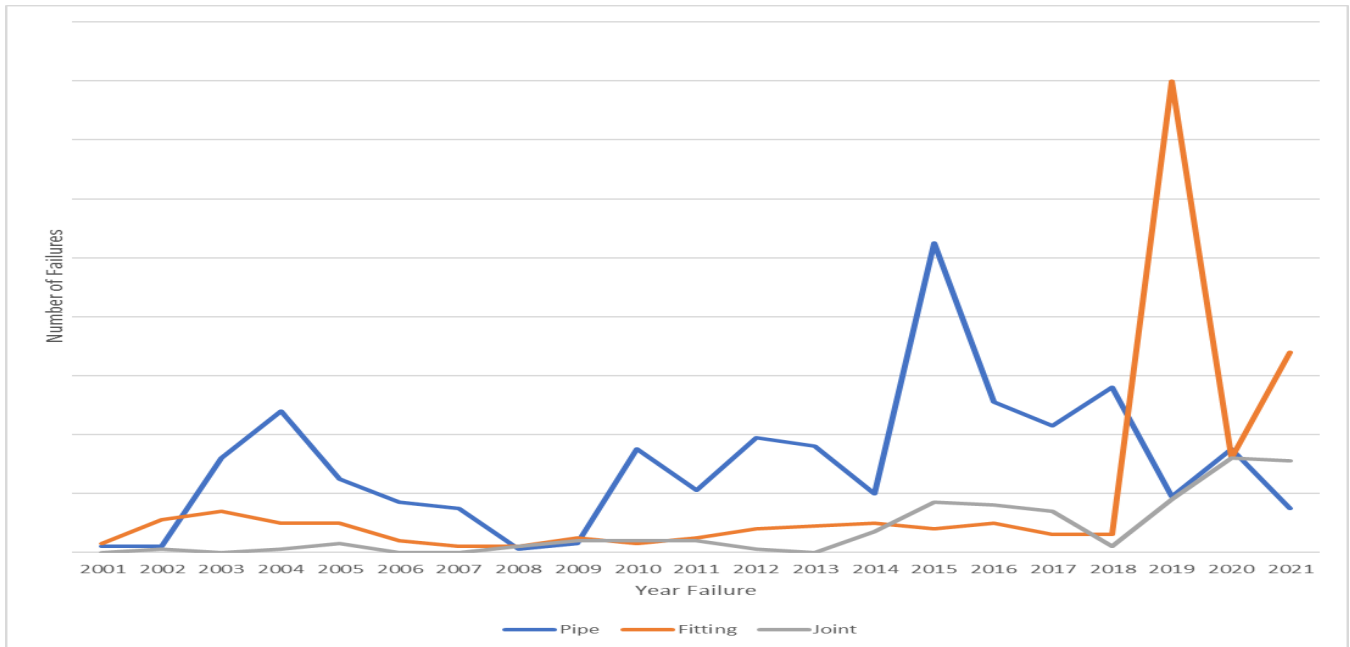
**Figure 2. Failures by Year of Failure as Reported to PPDC for PE3306**

Figure 2 shows the failures by year of failure. Of these PE3306 failures that have occurred, the majority of those with reported sizes (88%) are associated with service size piping (1” CTS in diameter or less) and 64% are ½” CTS.

Between 2019 and 2021, the total number of reported fittings failures exceeded the number of reported pipe failures. During this period, the top three reported fitting failures are: threaded caps at 45%, valves at 24%, and meter risers at 16%.”

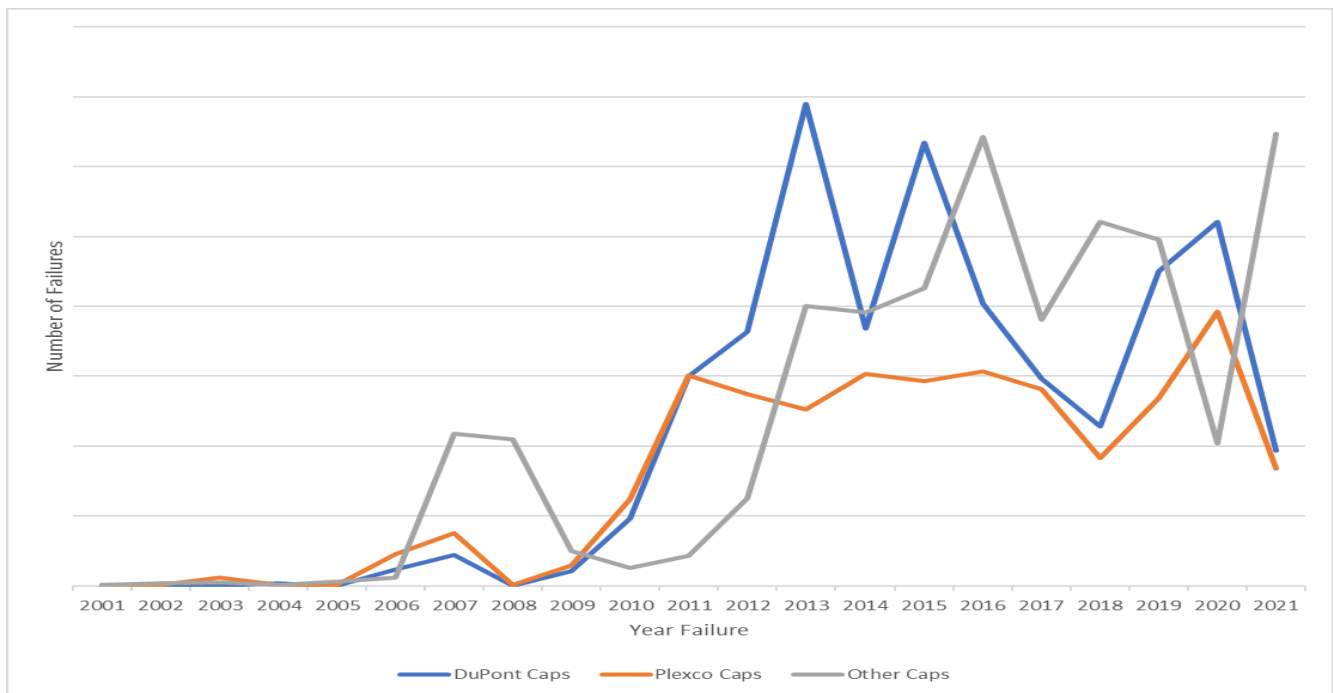
Figure 1. Failures by Year of Failure

Caps represent approximately 18% of all reports in the database and 40% of all fitting failures. Figure 1 shows elevated reports of cap failures in recent years.

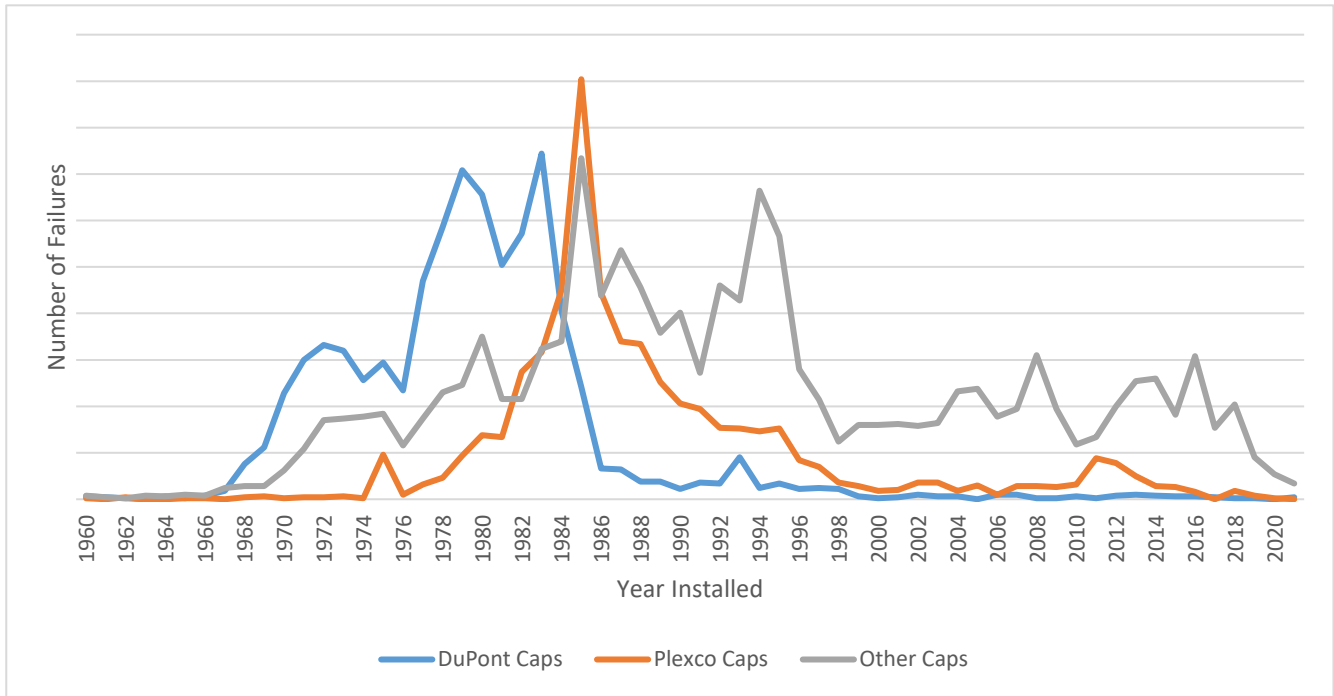
**Figure 2. Failures by Year Installed**

Figure 2 shows concentrations of failures in specific installation years for DuPont, Plexco and Other Manufacturers. The year of installation was reported for 42% of DuPont cap data, 43% of Plexco cap data, and 68% of Other Manufacturers cap data. Overall, the year of installation was reported for 53% for all cap data. The installation dates for DuPont and Plexco match what is historically known about the manufacturing timeframes. Because the year of installation data is limited, the DuPont and Plexco peaks identified below are underrepresented.

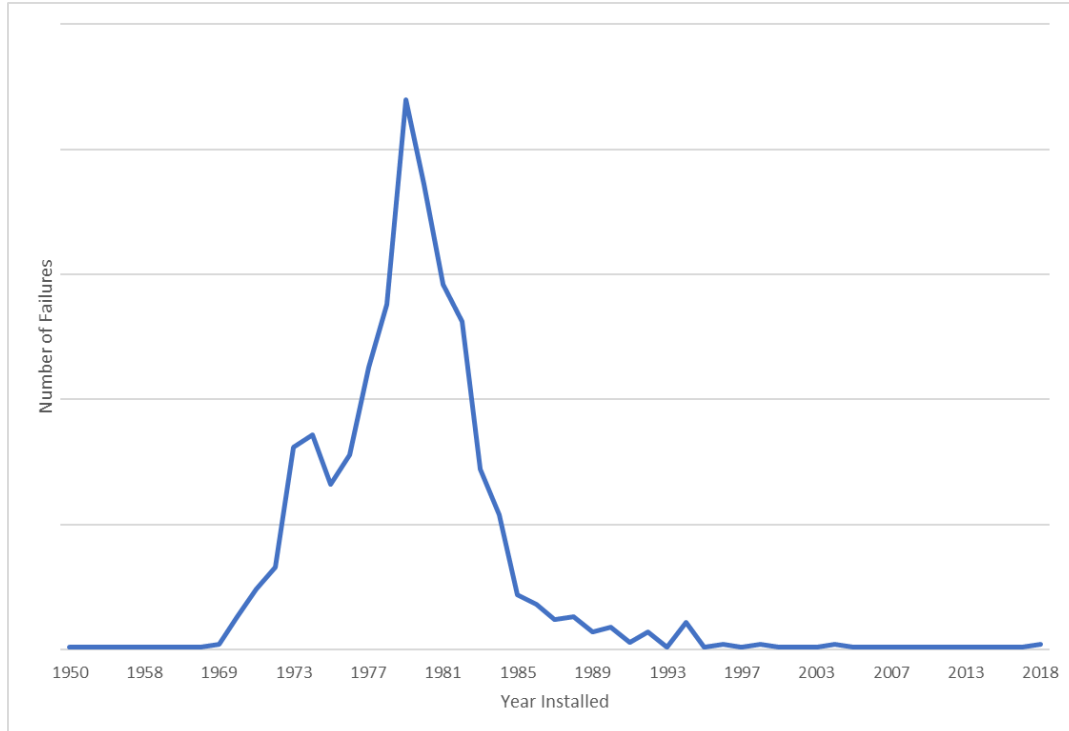
**Figure 1. AMP Failures by Year Installed**

Figure 1 shows AMP failures by year installed, which depicts the majority being installed between 1970 and 1990.

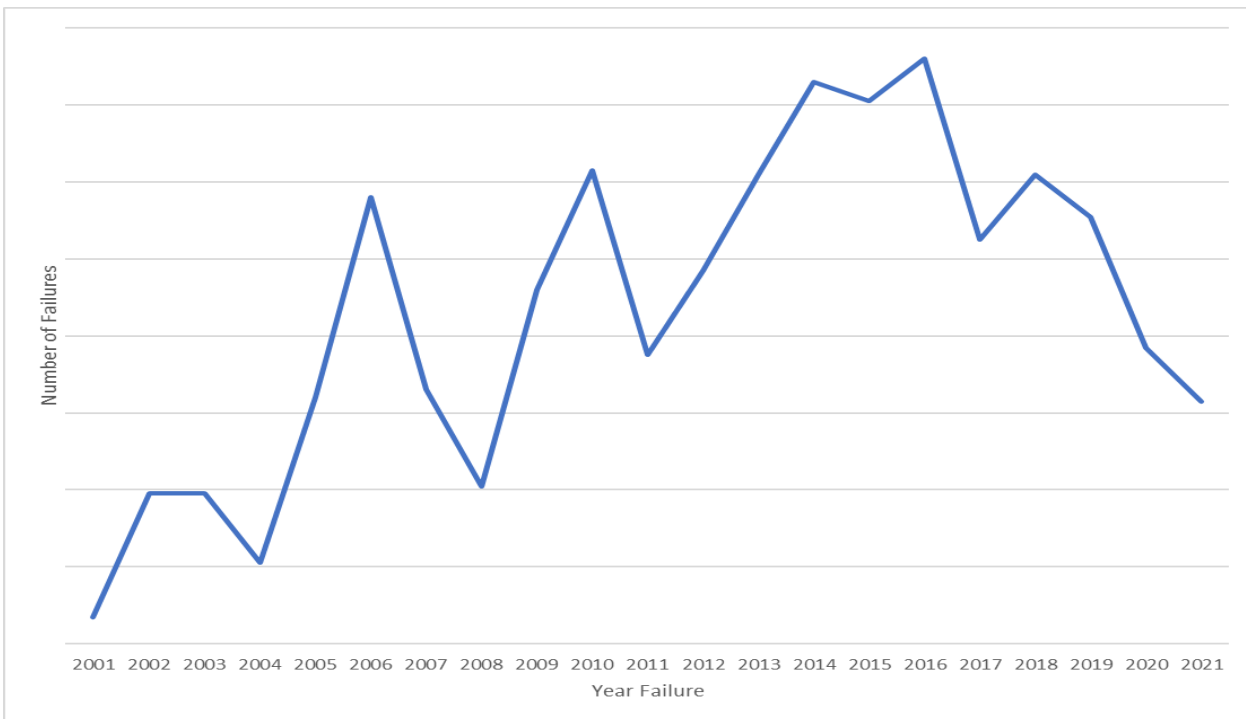
**Figure 3. AMP Failures by Year of Failure**

Figure 3 shows the failures by year of failure. The number of reported failures is variable across the years.

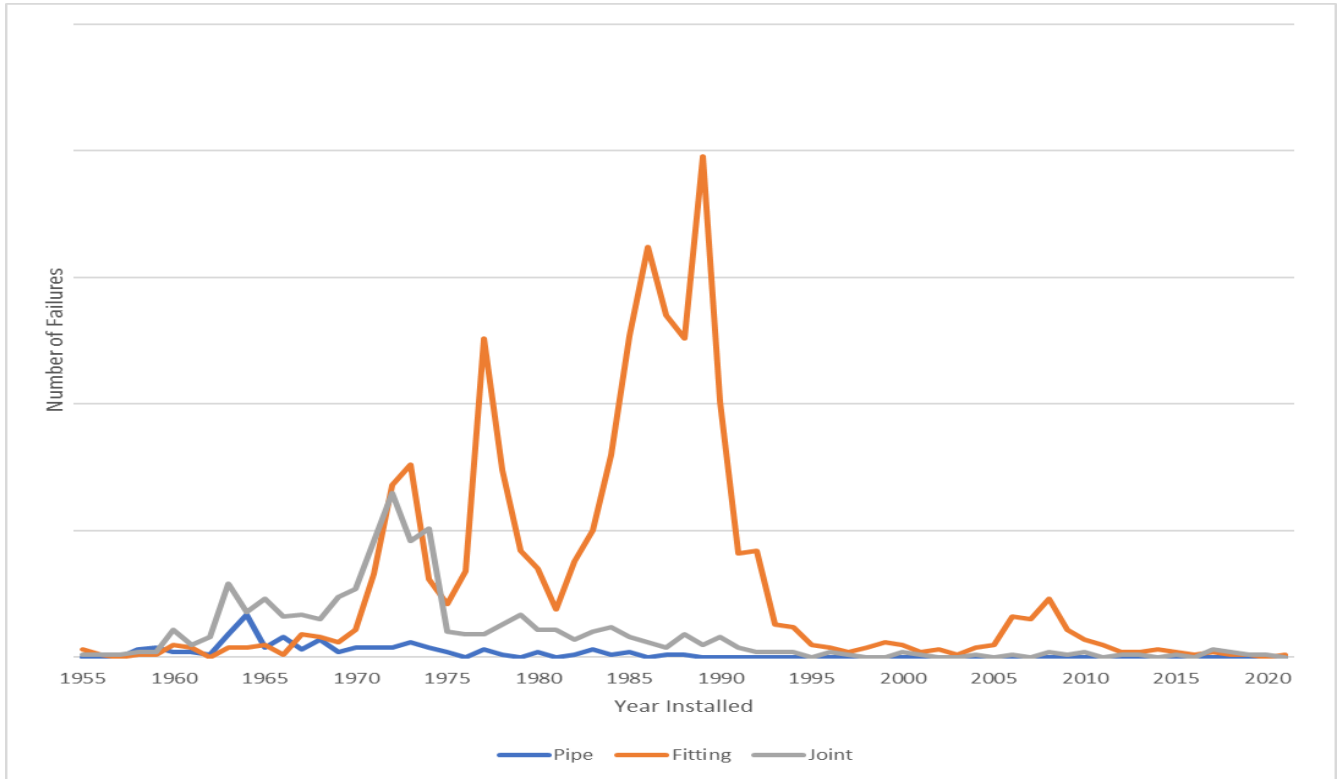
**Figure 2. PVC failures by Year Installed**

Figure 2 shows the failures by year installed. This chart also demonstrates the lack of pipe installation after the mid-1980s.

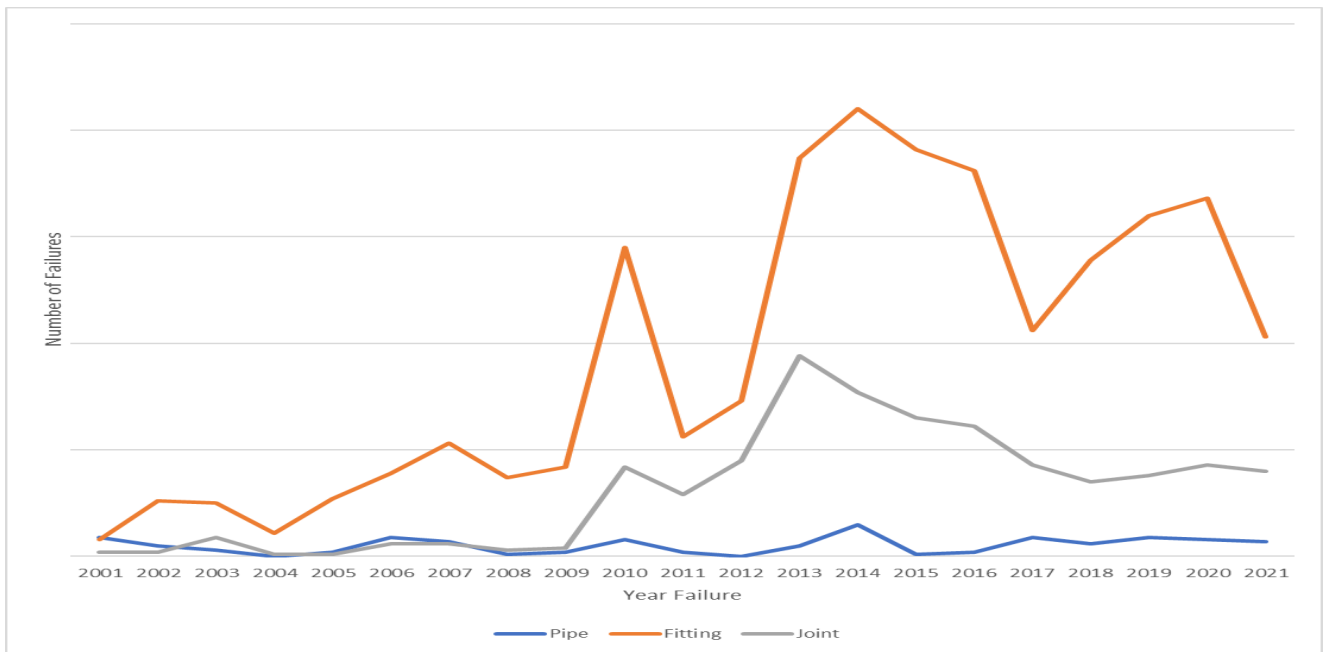
**Figure 3. PVC Failures by Year of Failure**

Figure 3 shows the failures by year of failure. The plot shows the trend of failures of fittings and joints.

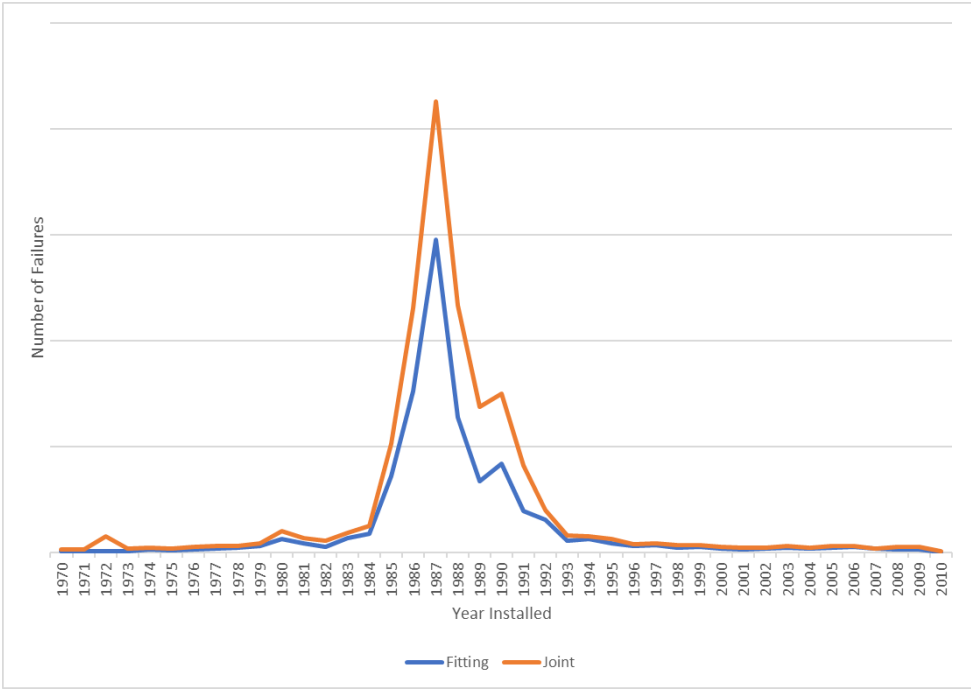
**Figure 1. Kerotest Fitting and Joint Failures by Year Installed**

Figure 1 shows Kerotest fittings and joint failures by year installed, which depicts the majority being installed between 1985 and 1992.

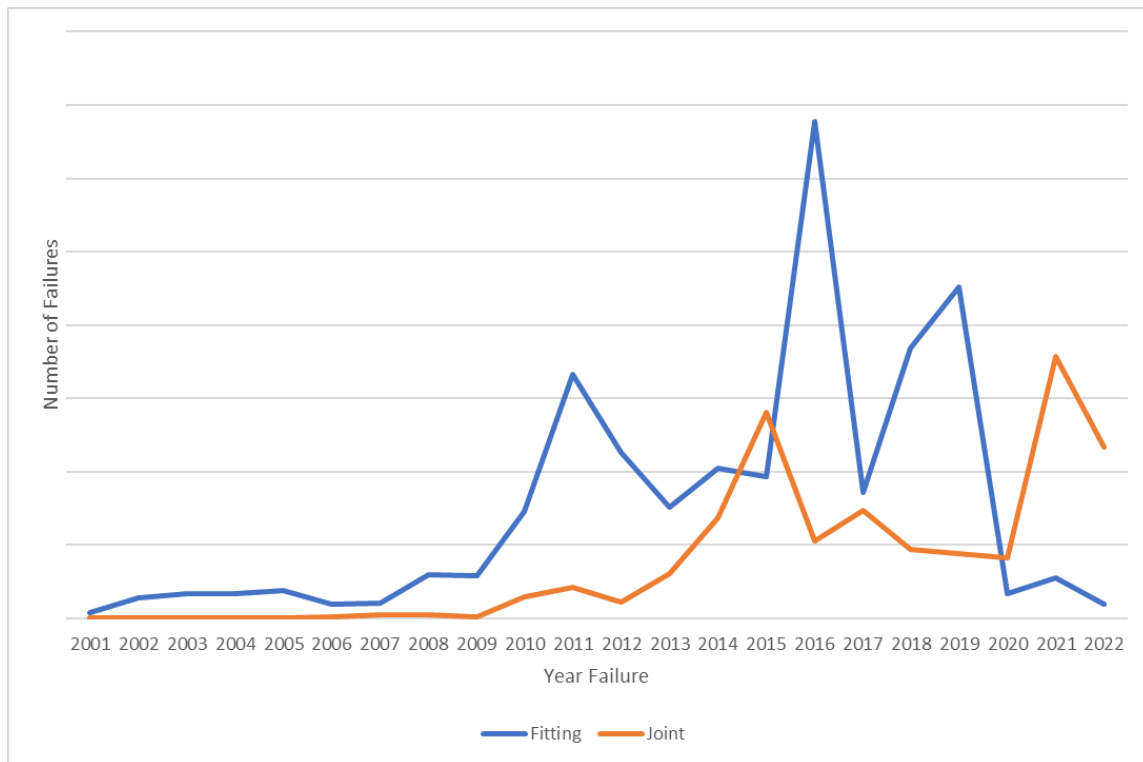
**Figure 2. Kerotest Fitting and Joint Failures by Year of Failure**

Figure 2 shows the Kerotest fitting and joint failures by year of failure and shows elevated reports in 2016 and 2018.

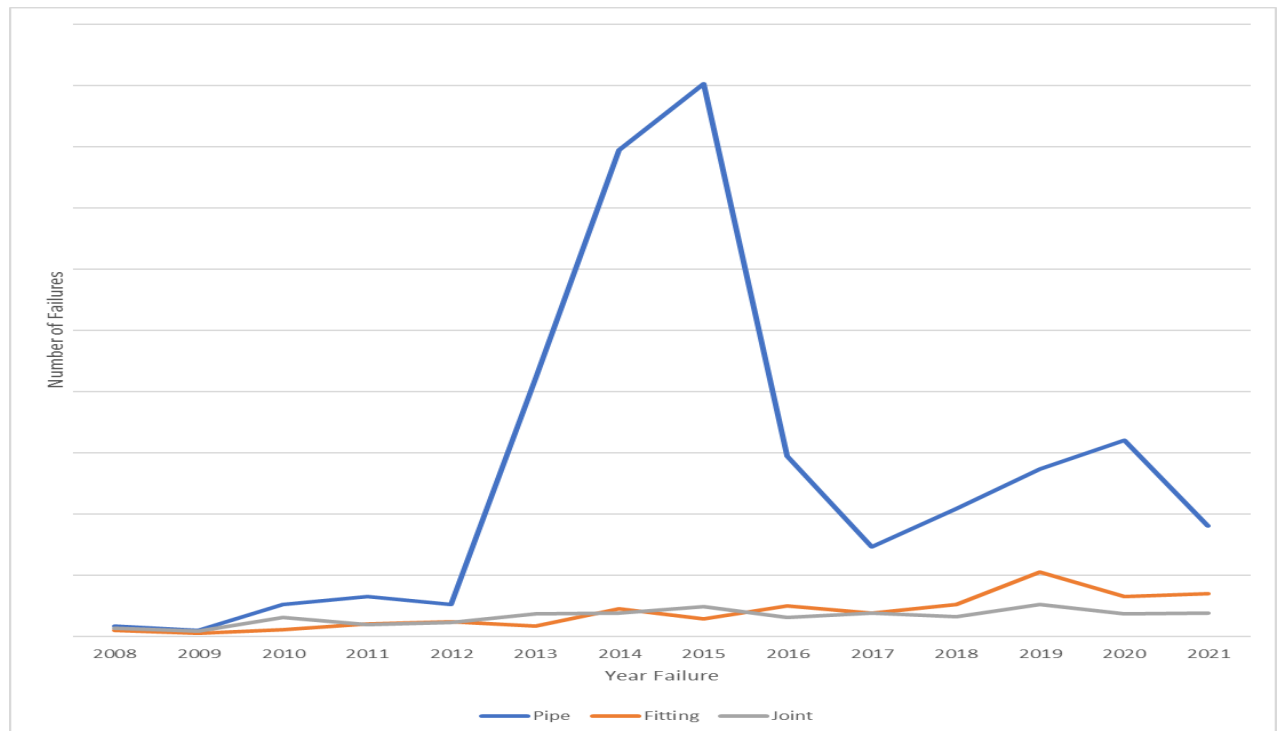
**Figure 2. Phillips Driscopipe HDPE Failures by Year of Failure**

Figure 2 shows Philips Driscopipe HDPE failures by year of failure. Following the various notifications in 2012, there was an immediate increase in reports to the PPDC.

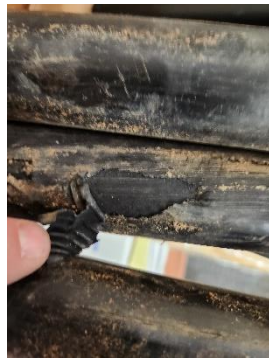
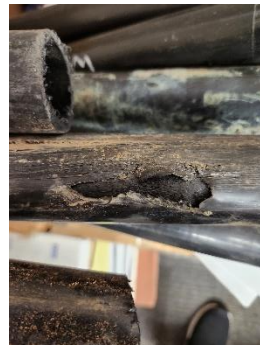
Figures 4 & 5 show external degradation is a peeling effect of the pipe.

**Response from PPDC:** A review of current PPDC data does not correspond with internal degradation processes. The PPDC will continue monitoring data for potential Drisco 8000 internal pipe wall issues with cracking and brittleness and external degradation of peeling of the pipe.
