PLASTIC PIPING DATA COLLECTION INITIATIVE STATUS REPORT

October 2022

Plastic Piping Data Collection Initiative

Status Report

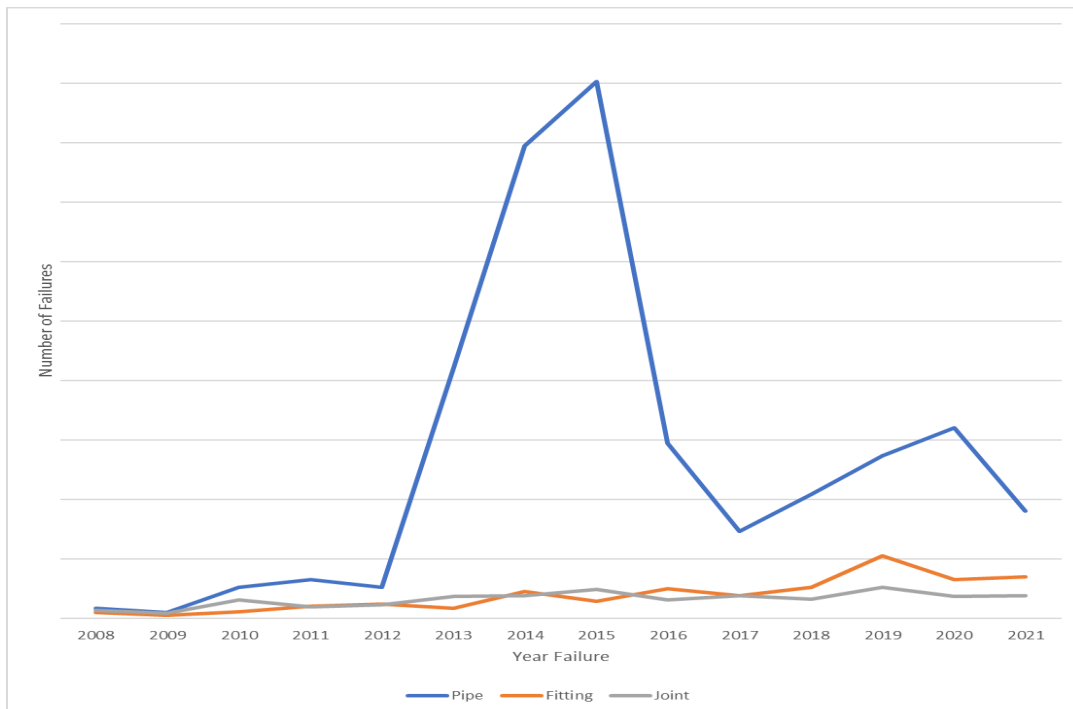
Figure 2. Phillips Driscopipe HDPE Failures by Year of Failure

Figure 2 shows Phillips Driscopipe HDPE failures by year of failure. Following the various notifications in 2012, there was an immediate increase in reports to the PPDC.
