PLASTIC PIPING DATA COLLECTION INITIATIVE STATUS REPORT

~~March-October~~ 2022

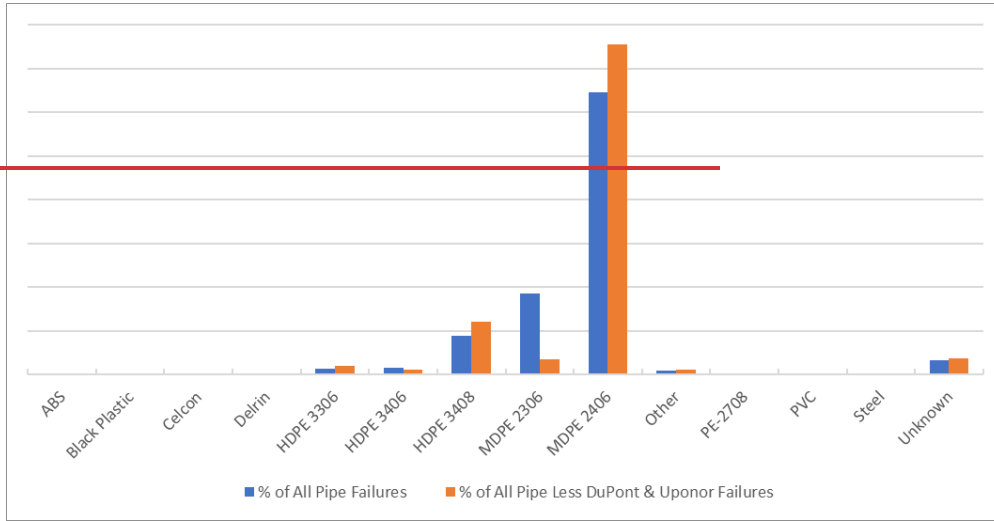
B2. All Pipe Failures by Material

Material	% of All Pipe Failures	% of All Pipe Less DuPont & Uponor Failures
ABS	0.1%	0.1%
Black Plastic	0.1%	0.2%
Celcon	0.0%	0.1%
Delrin	0.1%	0.0%
HDPE 3306	1.4%	1.9%
HDPE 3406	1.5%	1.1%
HDPE 3408	9.2%	12.4%
MDPE 2306	19.6%	4.8%
MDPE 2406	63.3%	73.8%
Other	0.9%	1.0%
PE-2708	0.4%	0.5%
PVC	0.3%	0.3%
Steel	0.1%	0.1%
Unknown	3.2%	3.7%
Total	100.0%	100.0%

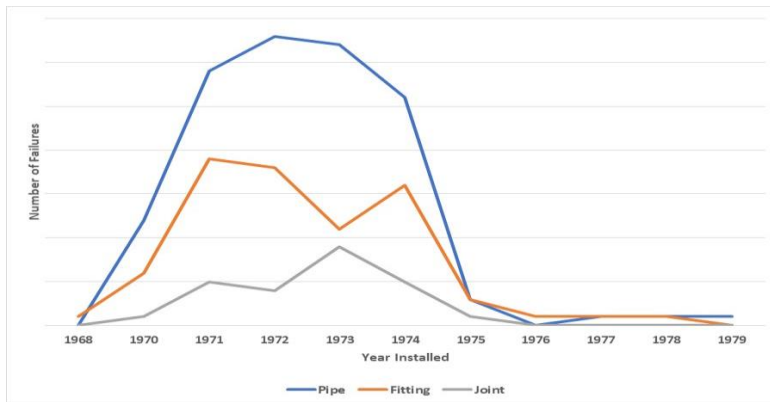
Century represent less than 1% of all the reports in the database. The majority of the reported Century failures occur on pipe (56%). Other categories include fittings (32%), joints (11%) and unknown (1%). The distribution of failures for pipe, fittings and joints by year installed is shown in Figure 1. The figure shows the majority of failures occurred on pipe installed from 1970 to 1974.

Figure 1. Failures by Years Installed as Reported to PPDC for Century Pipe, Fittings and Joints

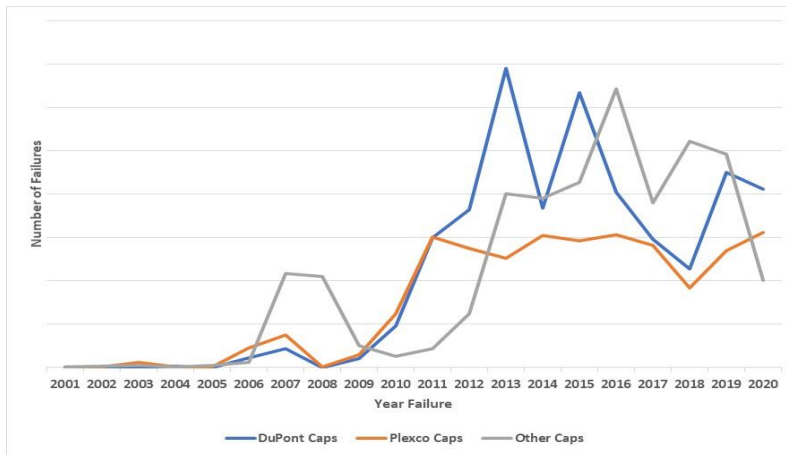
Caps represent approximately 19% of all reports in the database and 41% of all fitting failures. Figure 1 shows elevated reports of cap failures in recent years.

Figure 1. Failures by Year of Failure
