# **PLASTIC PIPING DATA COLLECTION INITIATIVE STATUS REPORT**

March 2022

**Administered by  
American Gas Association  
400 North Capitol Street, N.W., 4<sup>th</sup> Floor  
Washington, DC 20001  
U.S.A.**

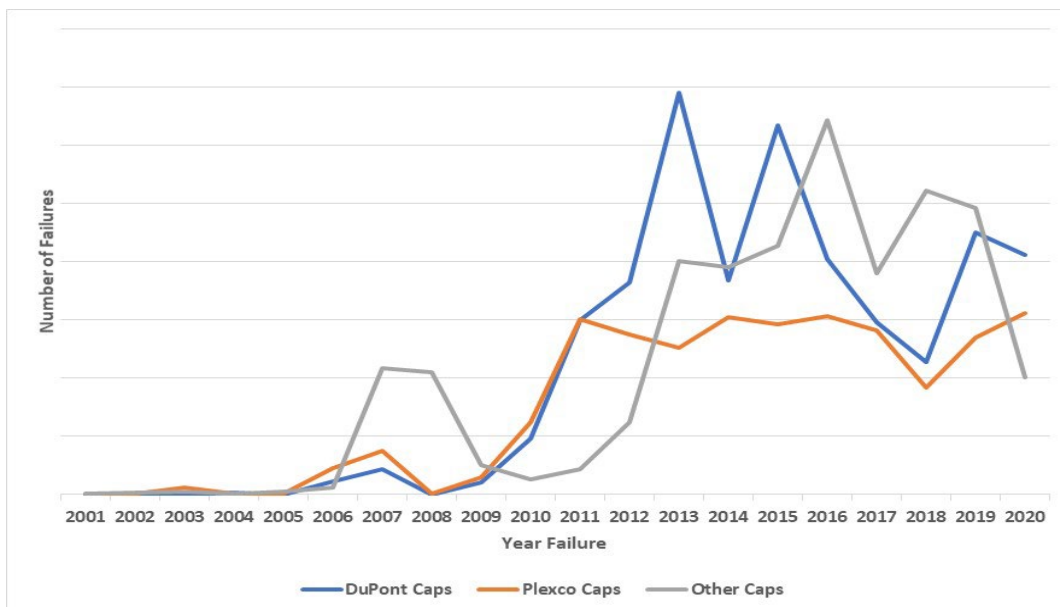
Caps represent approximately 19% of all reports in the database and 41% of all fitting failures. Figure 1 shows elevated reports of cap failures in recent years.

Figure 1. Failures by Year of Failure

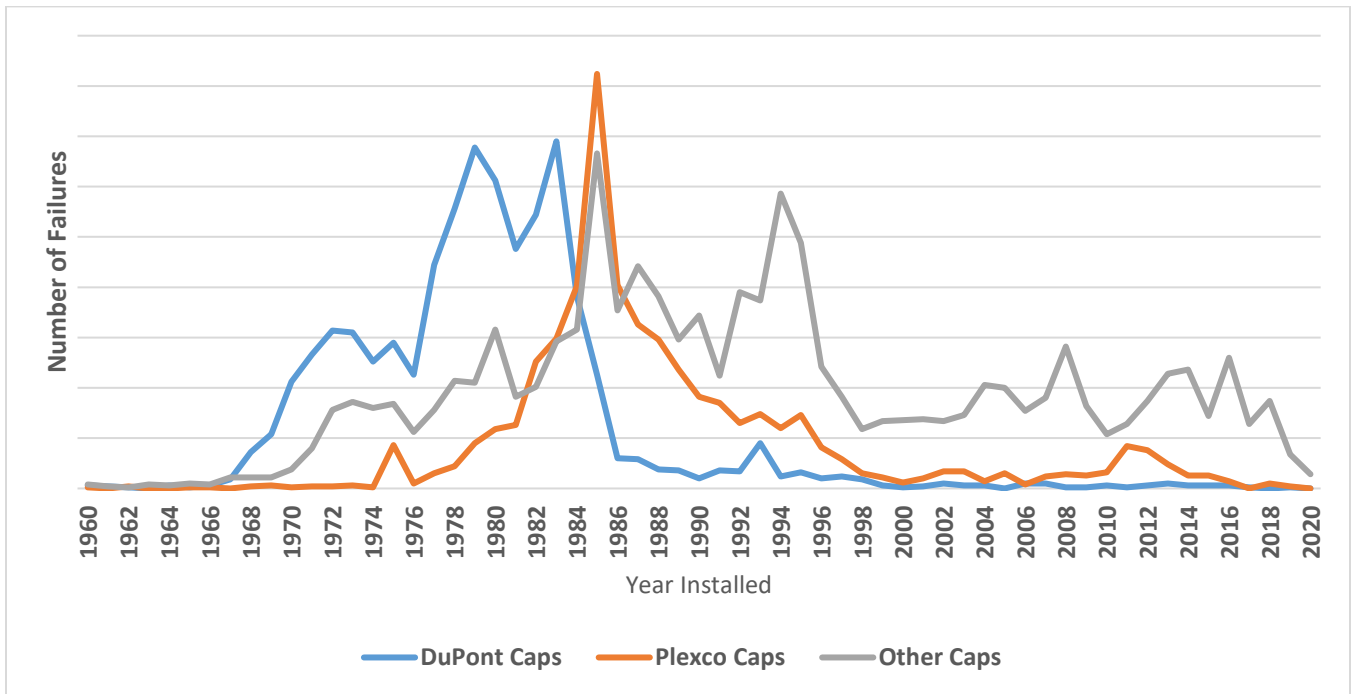
Figure 2 shows concentrations of failures in specific installation years for DuPont, Plexco and Other Manufacturers. The year of installation was reported for 42% of DuPont cap data, 42% of Plexco cap data, and 69% of Other Manufacturers cap data. Overall, the year of installation was reported for 62% for all cap data. The installation dates for DuPont and Plexco match what is historically known about the manufacturing timeframes. Because the year of installation data is limited, the DuPont and Plexco peaks identified below are underrepresented.

**Figure 2. Failures by Year Installed**
