PLASTIC PIPING DATA COLLECTION INITIATIVE STATUS REPORT

~~June 2021~~ March 2022

Administered by
American Gas Association
400 North Capitol Street, N.W., 4th Floor
Washington, DC 20001
U.S.A.

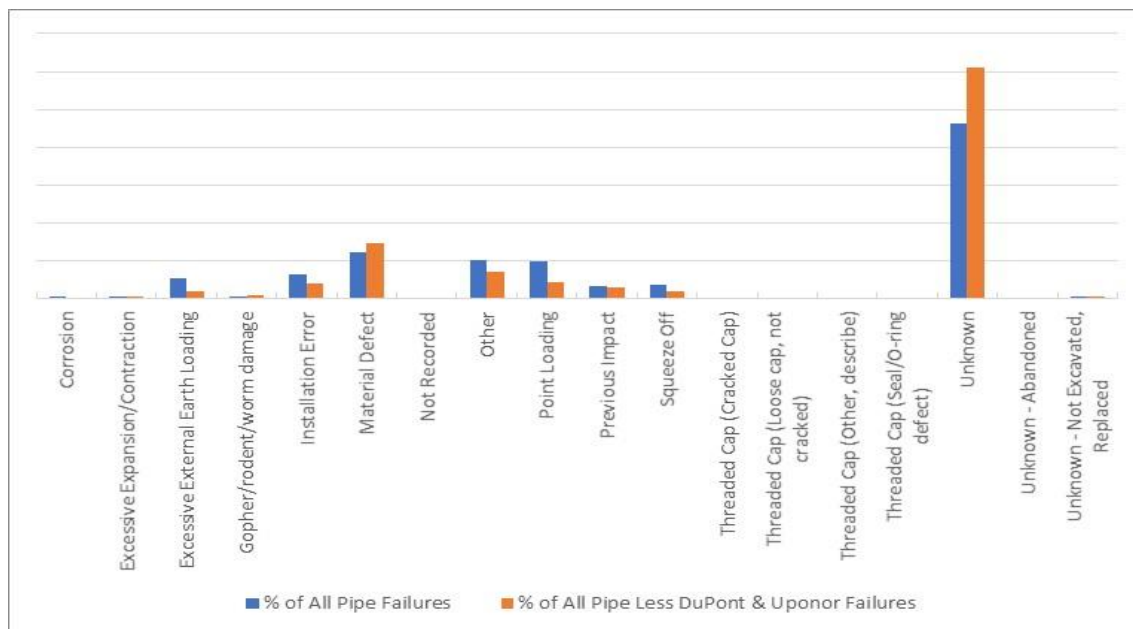
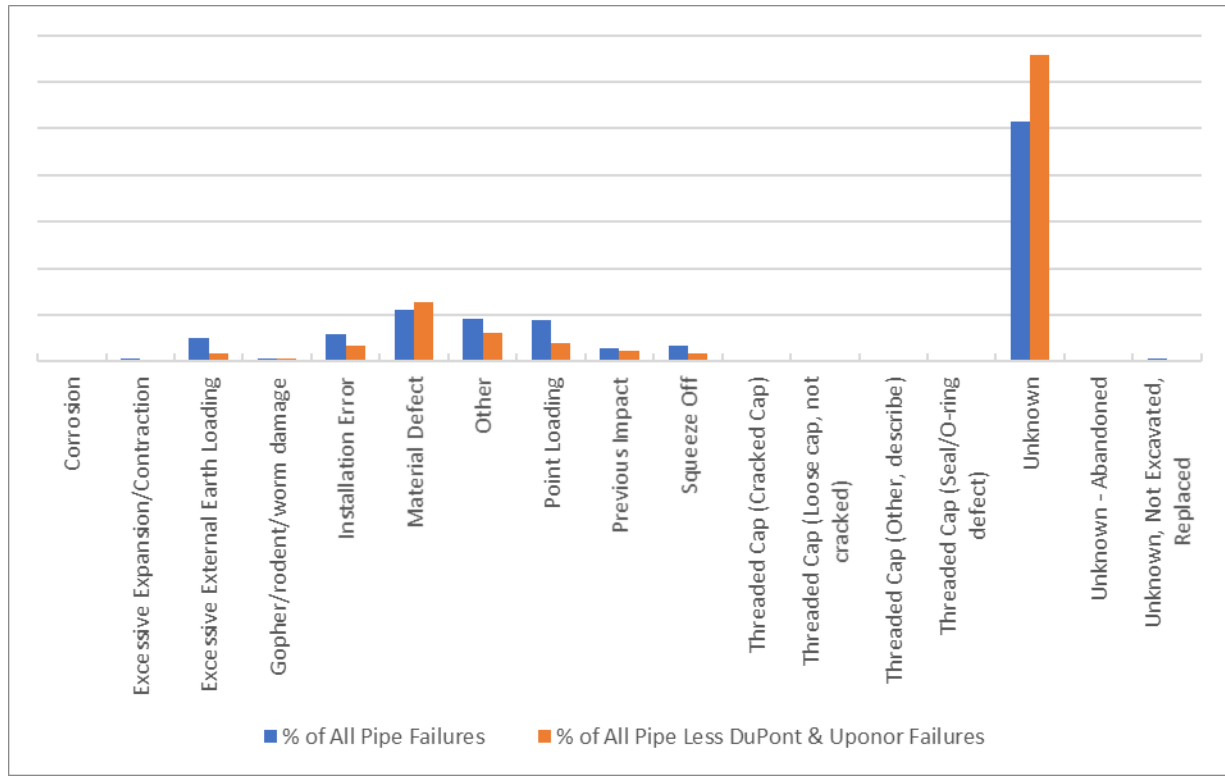
B1: All Pipe Failures by Cause

CAUSE	% of All Pipe Failures/Leaks	% of All Pipe Less DuPont & Uponor Failures/Leaks
Corrosion	0.4%	0.1%
Excessive Expansion/Contraction	0.6%	<u>0.40</u> 5%
Excessive External Earth Loading	<u>4.95</u> 4%	<u>1.82</u> 0%
Gopher/rodent/worm damage	<u>0.60</u> 7%	<u>0.70</u> 8%
Installation Error	<u>5.86</u> 4%	<u>3.43</u> 9%
Material Defect	<u>11.11</u> 2.3%	<u>12.61</u> 4.5%
Other	<u>9.21</u> 0.2%	<u>6.27</u> 0%
Point Loading	<u>8.89</u> 7%	<u>3.94</u> 5%
Previous Impact	<u>2.93</u> 2%	<u>2.42</u> 8%
Squeeze Off	<u>3.33</u> 6%	<u>1.72</u> 0%
Threaded Cap(Cracked Cap)	0.1%	0.1%
Unknown	<u>51.44</u> 6.3%	<u>65.86</u> 1.0%
Unknown – Abandoned	<u>0.20</u> 3%	0.2%
Unknown - Not Excavated, Replaced	<u>0.60</u> 7%	0.5%
TOTAL	100.0%	100.0%

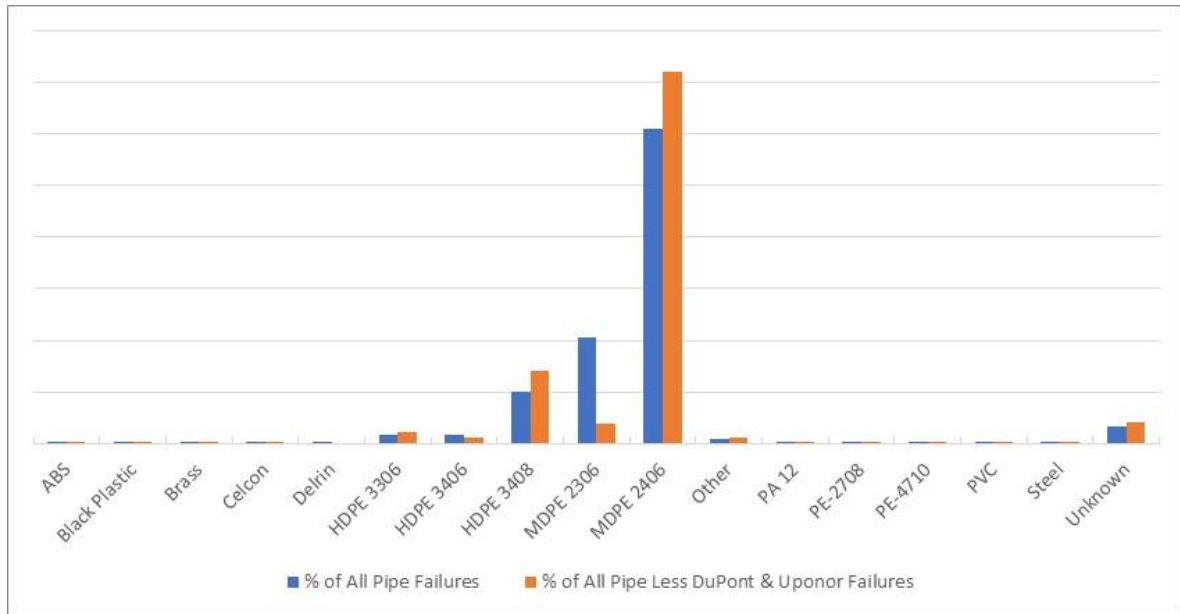
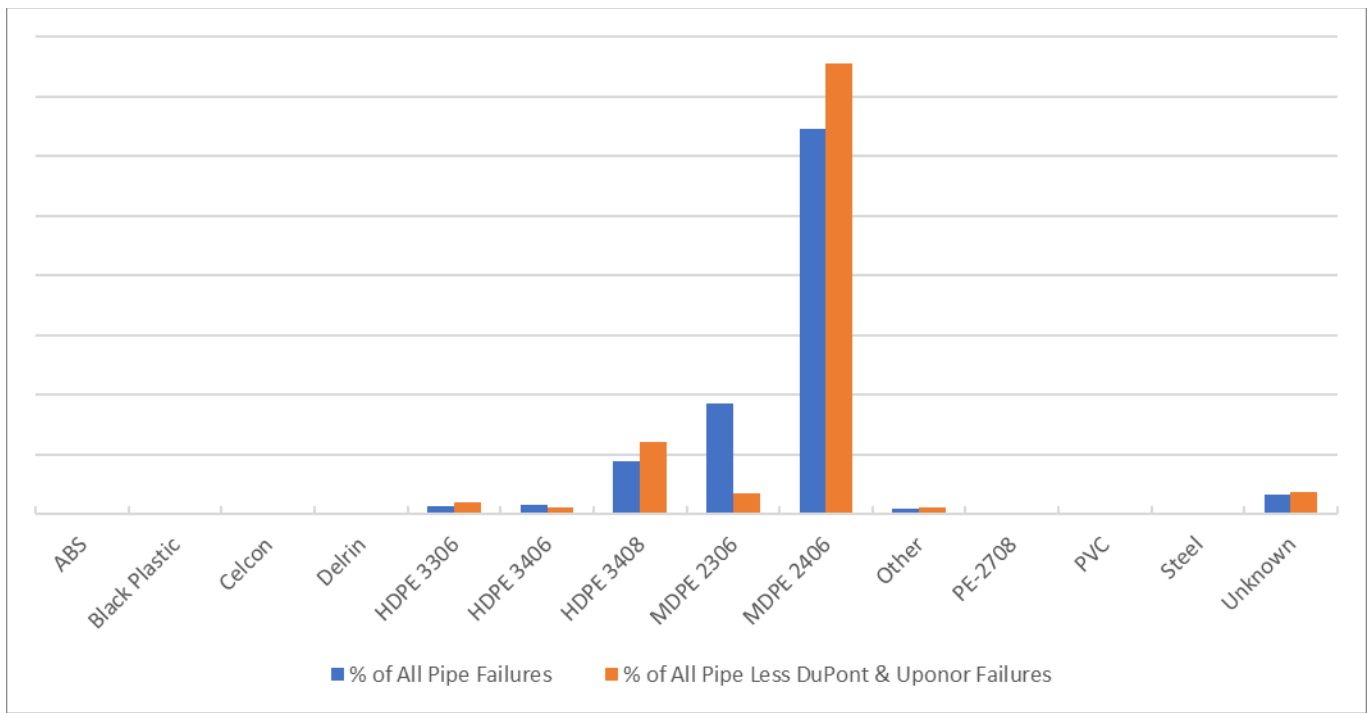
B2. All Pipe Failures by Material

Material	% of All Pipe Failures	% of All Pipe Less DuPont & Uponor Failures
ABS	0.1%	0.1%
Black Plastic	0.1%	0.2%
Celron	0.1%	0.1%
Delrin	0.1%	0.0%
HDPE 3306	<u>1.4</u> 1.6%	<u>1.9</u> 2.2%
HDPE 3406	<u>1.5</u> 1.7%	<u>1.0</u> 1.2%
HDPE 3408	<u>8.9</u> 9.9%	<u>12.0</u> 14.0%
MDPE 2306	<u>18.5</u> 20.5%	<u>3.4</u> 3.9%
MDPE 2406	<u>64.6</u> 60.9%	<u>75.6</u> 72.0%
Other	<u>0.9</u> 1.0%	<u>1.0</u> 1.2%
PE-2708	0.3%	0.4%
PVC	0.3%	<u>0.3</u> 0.4%
Steel	0.1%	0.1%
Unknown	<u>3.2</u> 3.3%	<u>3.8</u> 4.1%
Total	100.0%	100.0%

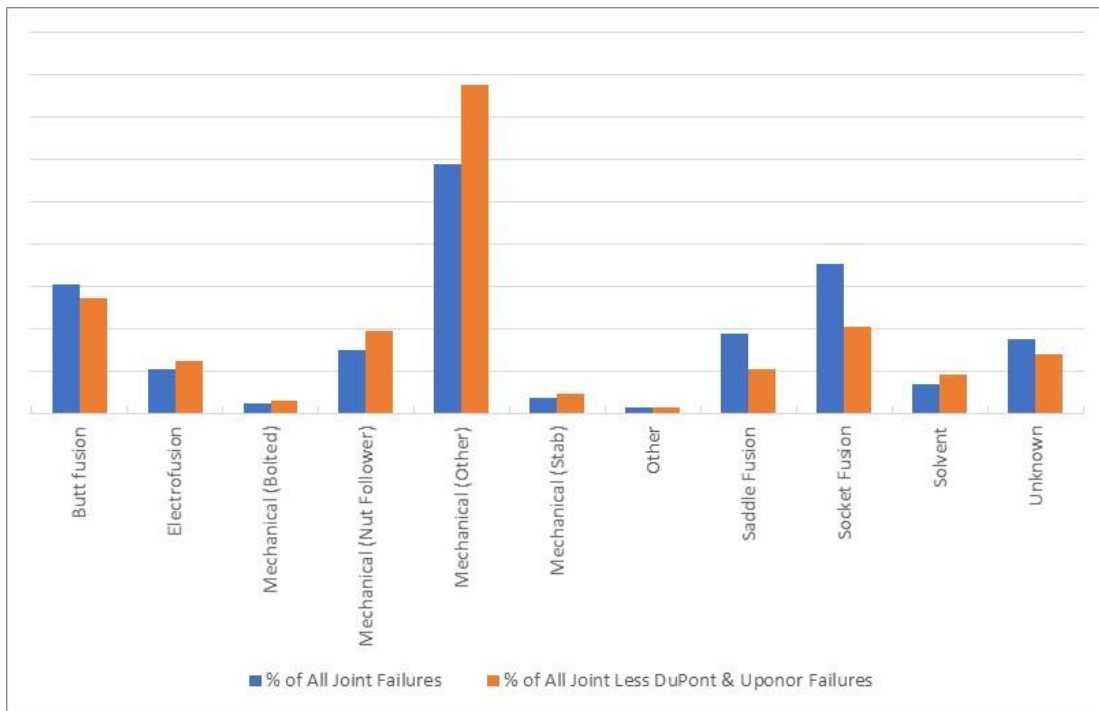
B6. All Joint Failures by Type

Joint	% of All Joint Failures	% of All Joint Less DuPont & Uponor Failures
Butt fusion	<u>15.0</u> 15.2 %	<u>13.5</u> 13.7 %
Electrofusion	<u>5.1</u> 5.2 %	<u>6.1</u> 6.2 %
Mechanical (Bolted)	1.1%	<u>1.4</u> 1.5 %
Mechanical (Nut Follower)	<u>7.2</u> 7.4 %	<u>9.4</u> 9.7 %
Mechanical (Other and Unknown)	<u>30.1</u> 29.5 %	<u>39.4</u> 38.8 %
Mechanical (Stab)	1.8%	2.3%
Other	0.6%	0.8%
Saddle Fusion	9.4%	<u>5.4</u> 5.3 %
Socket Fusion	17.7%	<u>10.4</u> 10.3 %
Solvent	<u>3.3</u> 3.4 %	<u>4.5</u> 4.6 %
Unknown	<u>8.6</u> 8.7 %	7.0%
Total	100.0%	100.0%

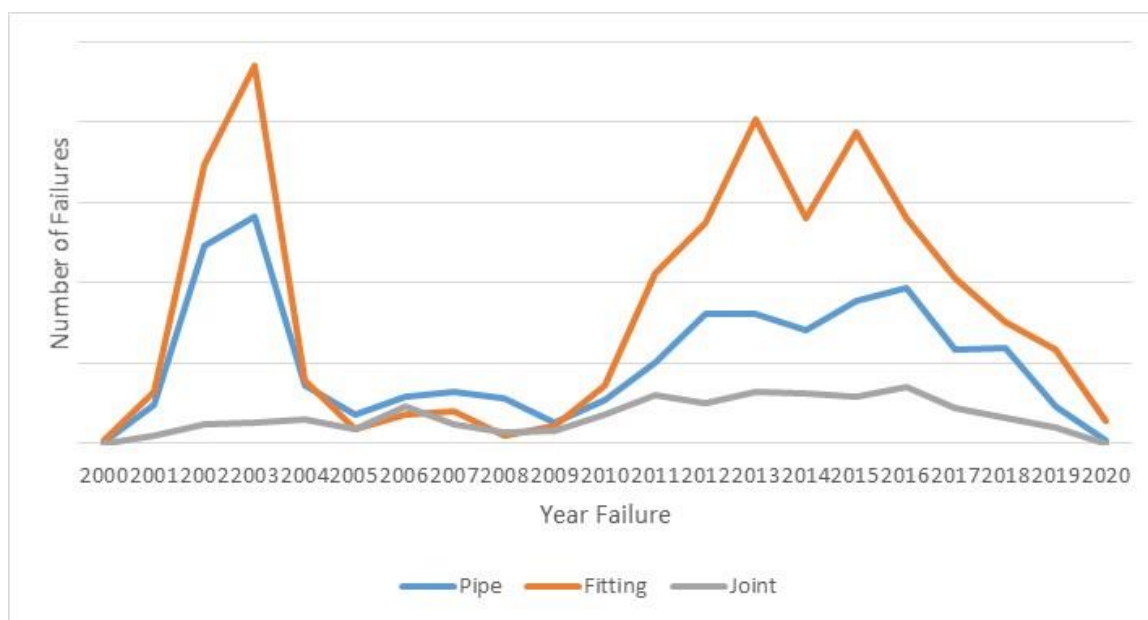
DuPont and Uponor represent approximately 3227% of all the reports in the database. Figure 1 shows the failures by year of failure. As reflected in the graph, there has been a recent increase in data submitted to the database. The majority of the reported Aldyl failures occur on fittings (5654%). Other categories include pipe (3233%), joints (11%) and unknown (12%).

Figure 1. Failures by Year of Failure as reported to PPDC for Aldyl.

Table 1 reflects an analysis of the ~~three two~~ peaks from Figure 1, ~~comparing showing~~ a change in fitting type failures from 2000-2005, ~~2010-2015 and compared to 2016-2021~~ 2010-2015 and 2016-2021. Noting the increase in Cap-type failures, reference Appendix F for more detailed analysis on Caps.

Figure 3 shows the failures by Year Installed. Although Figure 1 shows ~~threetwo~~ data peaks, the year of installation range appears consistent.

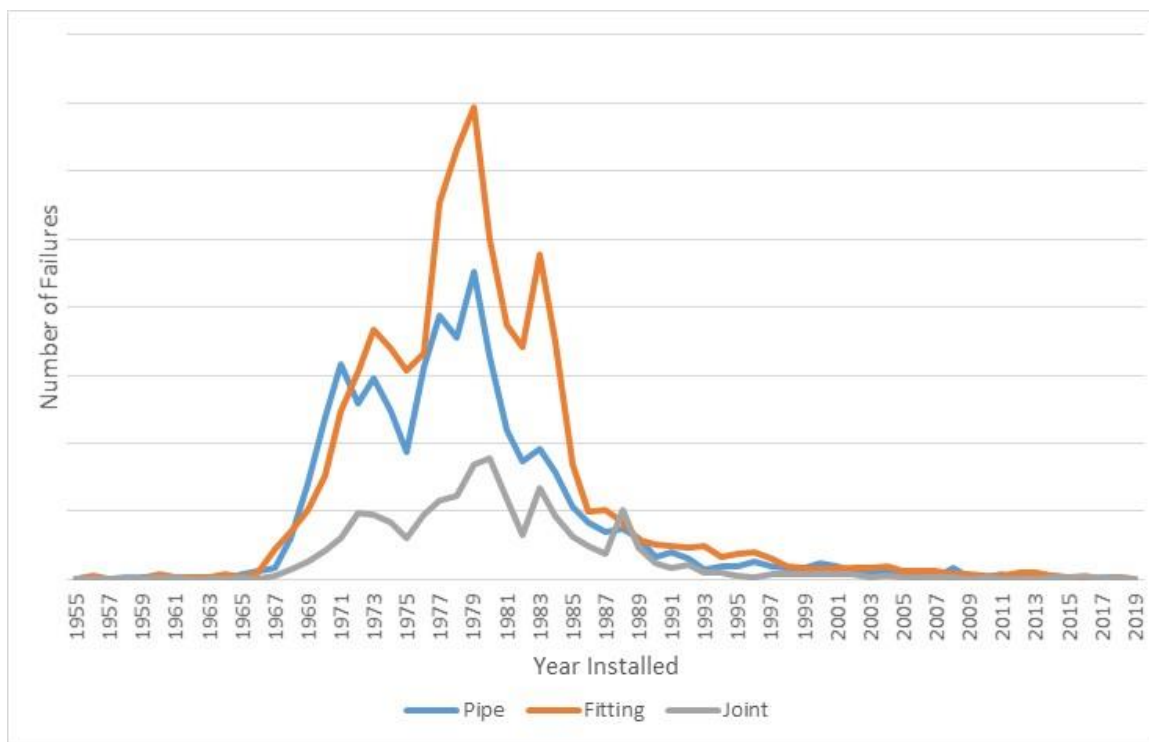
Figure 3. Failures by Year Installed as reported to PPDC for Aldyl pipe, fittings and joints

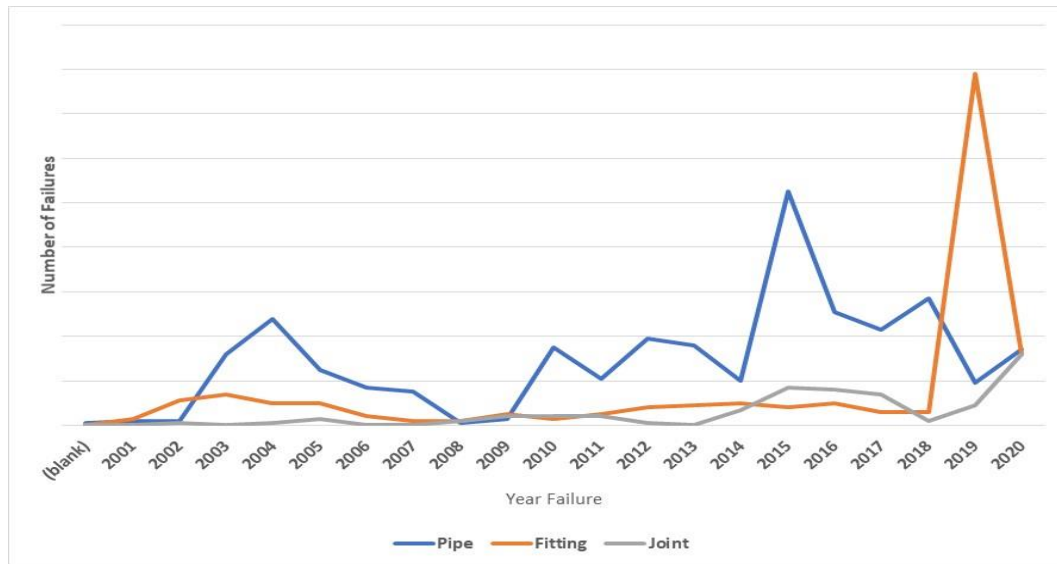
Figure 2 shows the failures by year of failure. Of these PE3306 failures that have occurred, the majority of those with reported sizes (90%) are associated with service size piping (1" CTS in diameter or less) and 75% are ½" CTS.

As a result of recent entries, the data on types of failures has changed. Specifically, failures involving fittings now exceed pipe failures. The 2019 spike on fittings is due to threaded caps (56%), valves (28%) and mechanical nut follower (16%).

Figure 2. Failures by Year of Failure as Reported to PPDC for PE3306

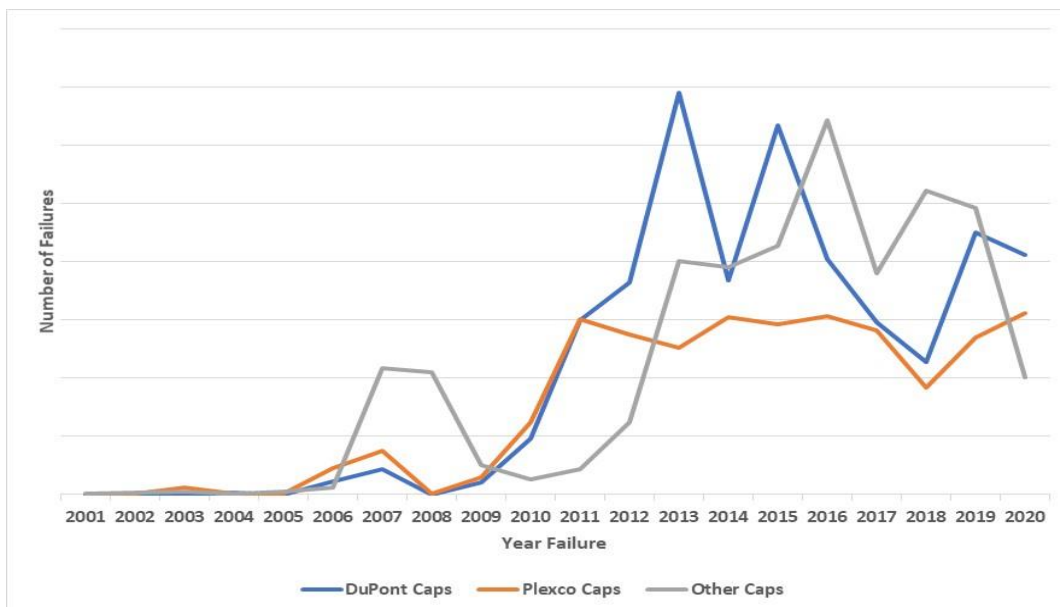
Caps represent approximately 19% of all reports in the database and 41% of all fitting failures. Figure 1 shows elevated reports of cap failures in recent years.

Figure 1. Failures by Year of Failure
