PLASTIC PIPING DATA COLLECTION INITIATIVE STATUS REPORT

~~October 2022~~ February 2023

Administered by
American Gas Association
400 North Capitol Street, N.W., 4th Floor
Washington, DC 20001
U.S.A.

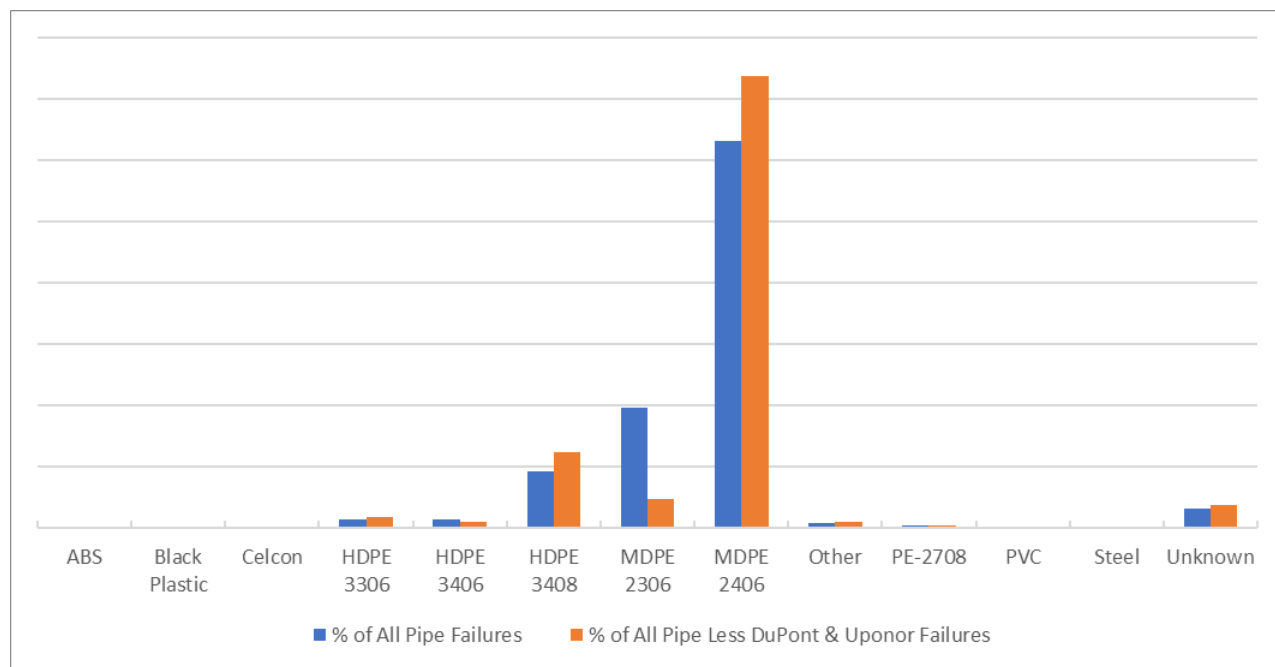
B2. All Pipe Failures by Material

Material	% of All Pipe Failures	% of All Pipe Less DuPont & Uponor Failures
ABS	0.1%	0.1%
Black Plastic	0.1%	0.2%
Celcon	0.0%	0.1%
HDPE 3306	1.4%	1.9%
HDPE 3406	1.5%	1.1%
HDPE 3408	9.2%	12.3 12.4%
MDPE 2306	19.9 19.6%	5.4 4.8%
MDPE 2406	62.9 63.3%	73.3 73.8%
Other	0.9%	1.0%
PE-2708	0.4%	0.5%
PVC	0.3%	0.3%
Steel	0.1%	0.1%
Unknown	3.2%	3.8 3.7%
Total	100.0%	100.0%

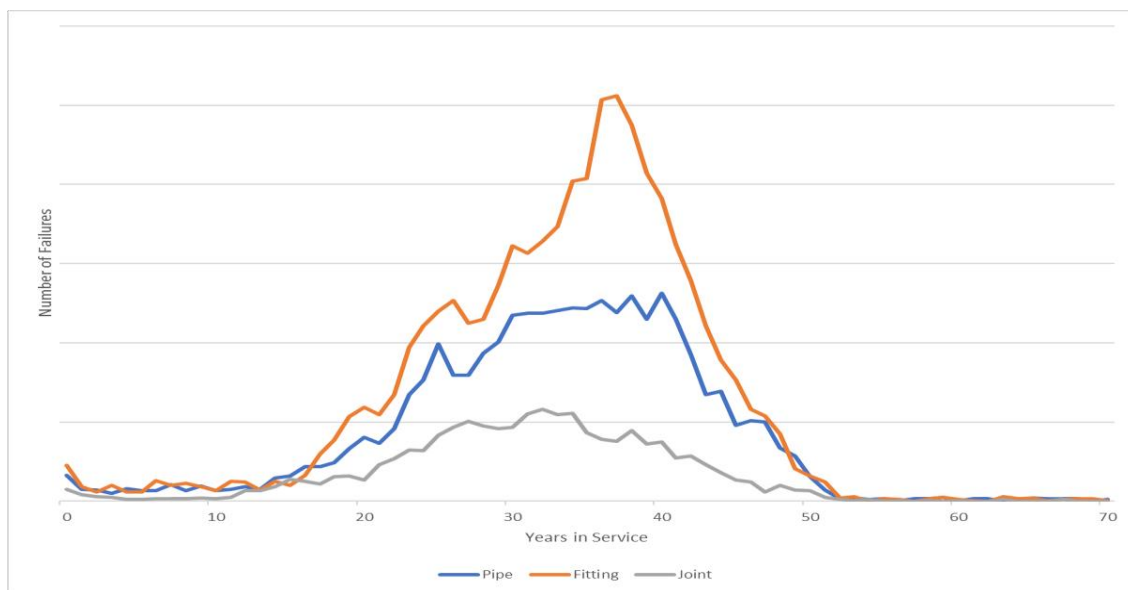
Figure 2. Failures by Years in Service as reported to PPDC for Aldyl pipe, fittings and joints

The distribution of the Years in Service of failures is similar for pipe, fittings and joints (Figure 2).

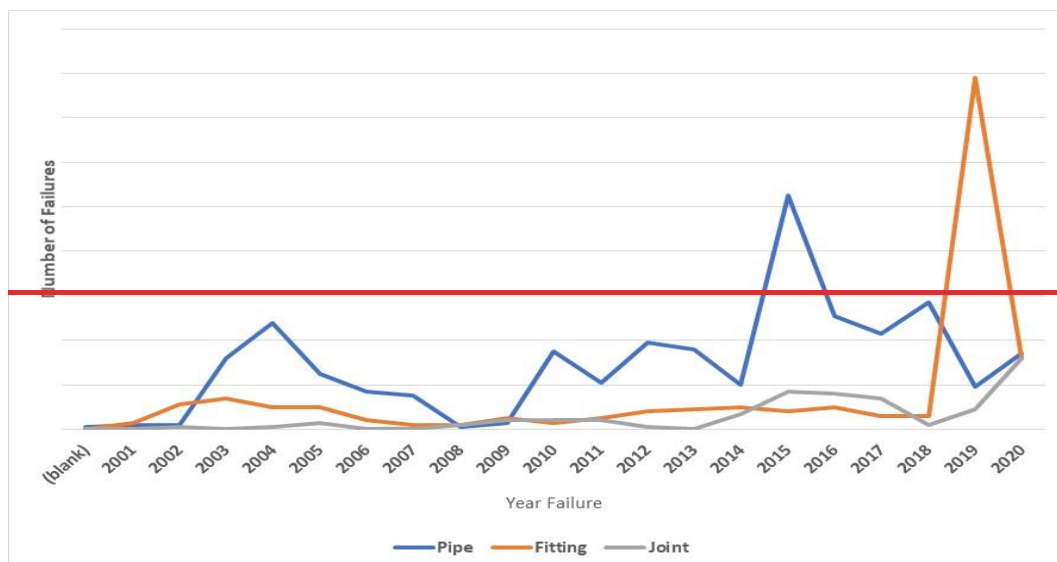
Figure 2. Failures by Year of Failure as Reported to PPDC for PE3306

Figure 2 shows the failures by year of failure. Of these PE3306 failures that have occurred, the majority of those with reported sizes (8890%) are associated with service size piping (1” CTS in diameter or less) and 6475% are ½” CTS.

Between 2019 and 2021, the total number of reported fittings failures exceeded the number of reported pipe failures. During this period, the top three reported fitting failures are: threaded caps at 45%, valves at 24%, and meter risers at 16%.”

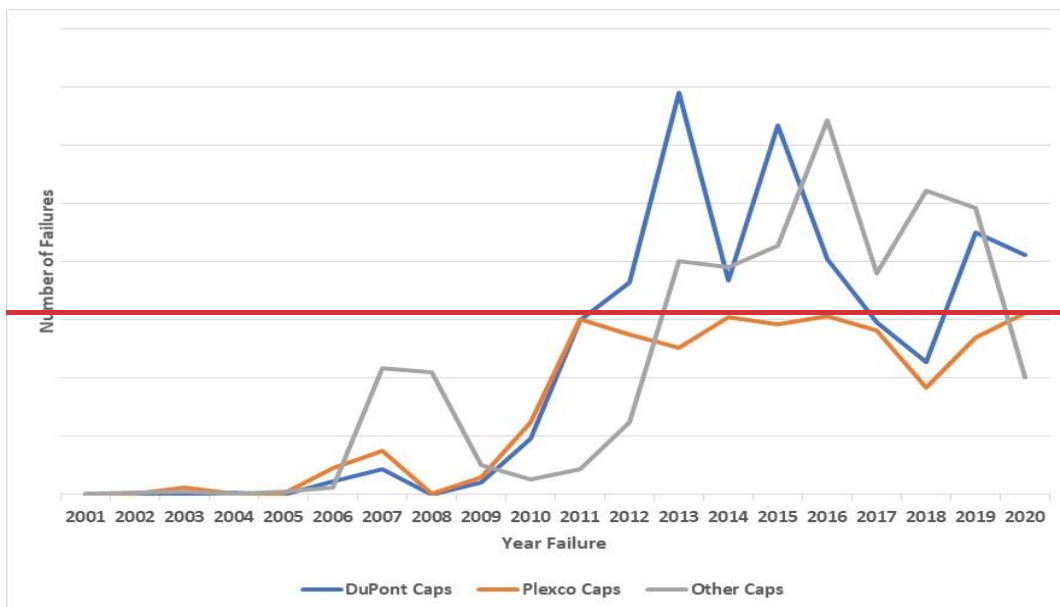
Figure 1. Failures by Year of Failure

Caps represent approximately ~~18~~¹⁹% of all reports in the database and ~~40~~⁴¹% of all fitting failures. Figure 1 shows elevated reports of cap failures in recent years.

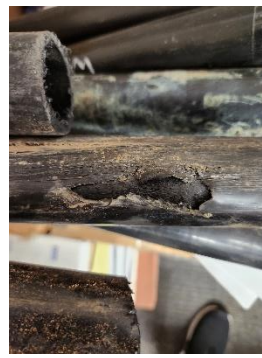
Figure 5

Figures 4 & 5 show external degradation is a peeling effect of the pipe.

Response from PPDC: A review of current PPDC data does not correspond with internal degradation processes. The PPDC will continue monitoring data for potential Drisco 8000 internal pipe wall issues with cracking and brittleness and external degradation of peeling of the pipe.
