Plastic Pipe
Database
Committee

What's New with Plastic Piping May 2023

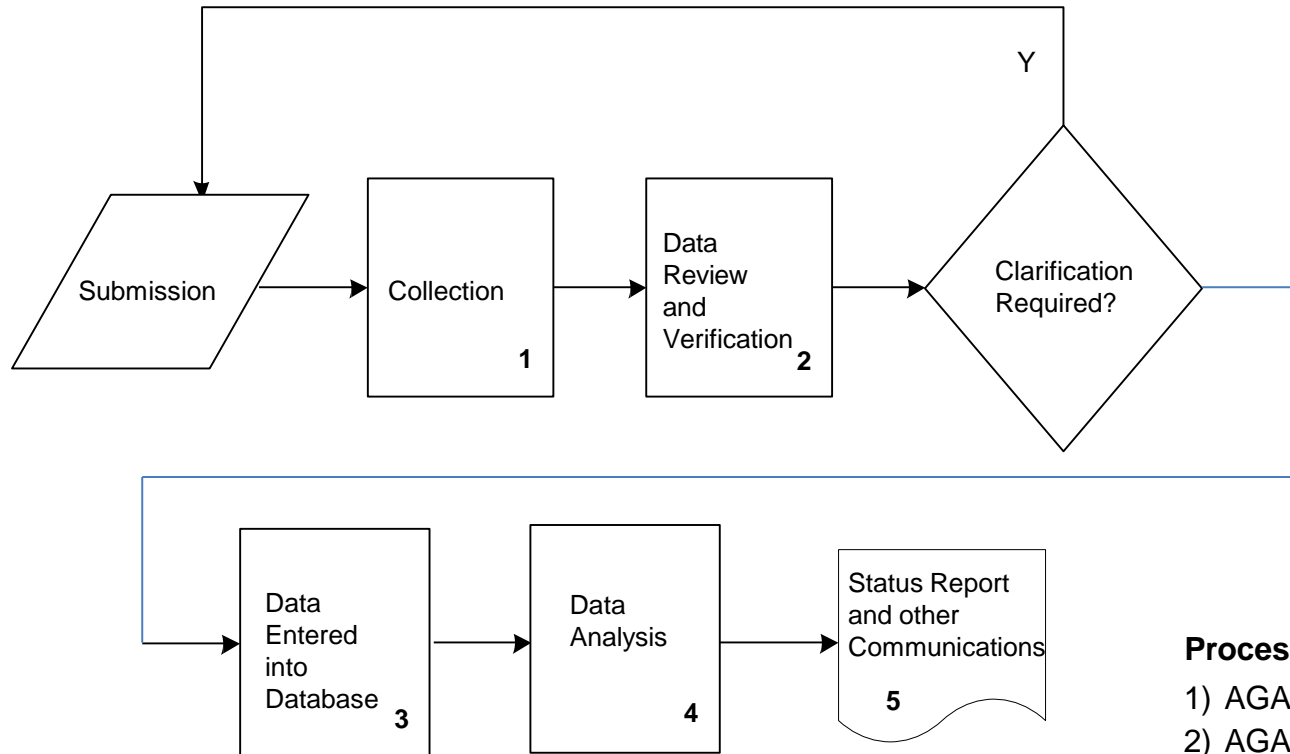
Plastic Pipe Database Committee Data Process Flow

Process Responsibilities

- 1) AGA Data Collection Team
- 2) AGA Data Collection Team
- 3) AGA Data Collection Team
- 4) Plastic Pipe Database Committee
- 5) AGA Data Collection Team / PPDC

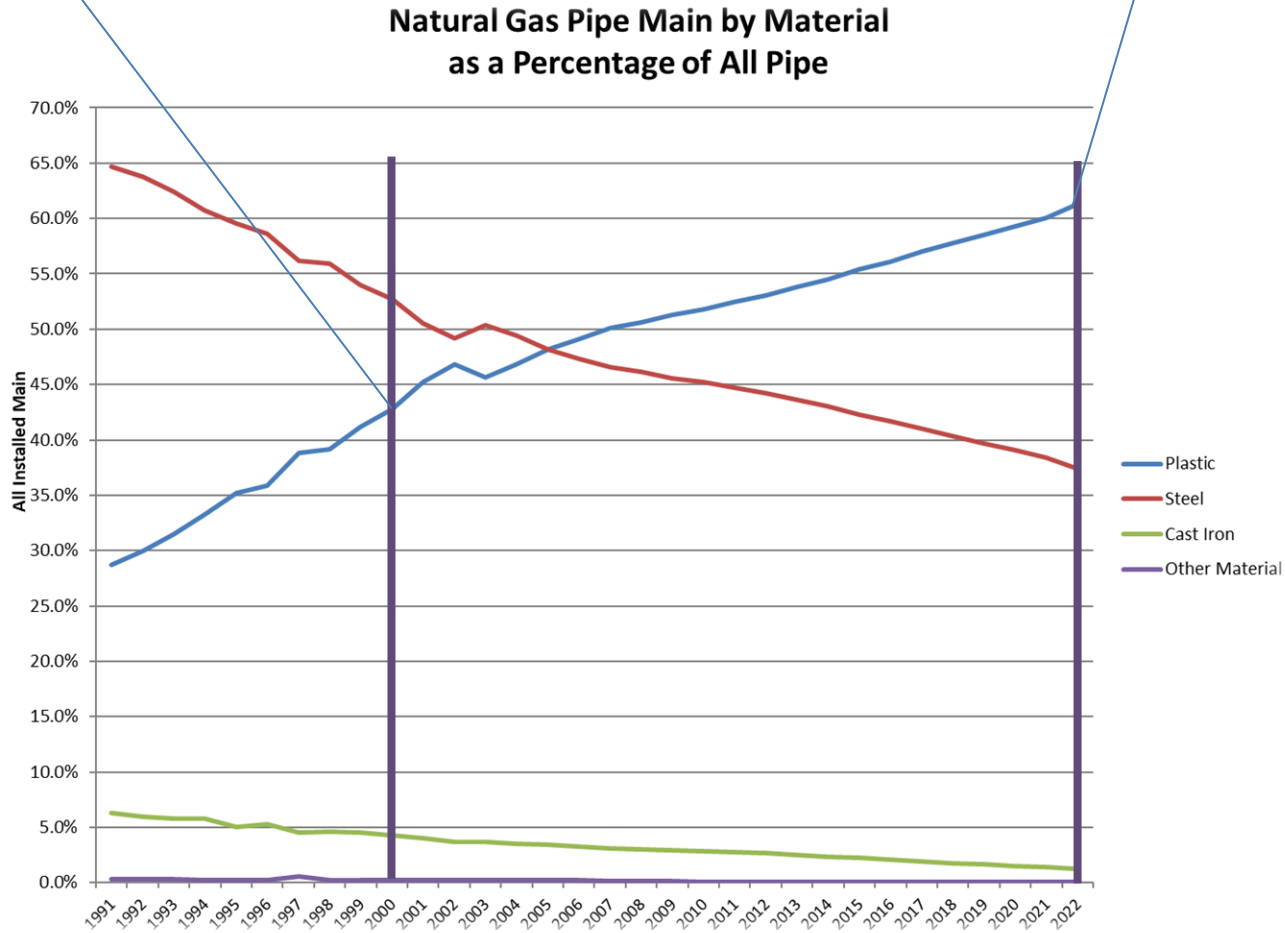
PHMSA Database

Plastic 61.3% of all mains
Total miles of Plastic main = 839,623

PHMSA annual report data downloaded 4/20/2023

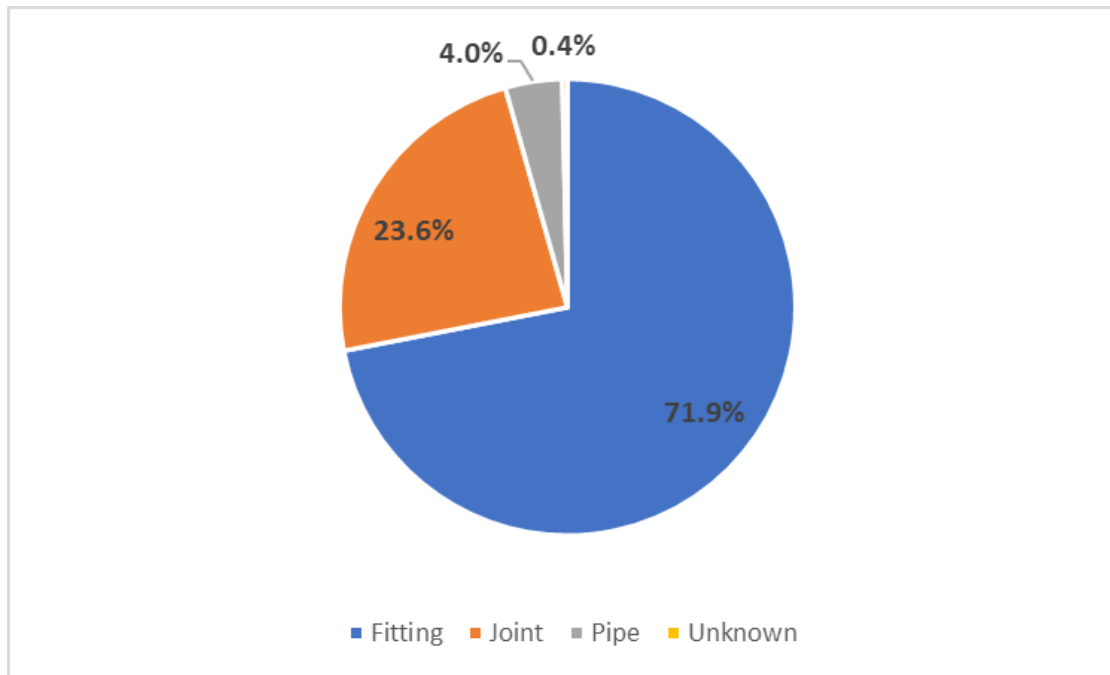
PVC Failures by Location

According to data submitted to PHMSA on annual reports, mileage for PVC has been decreasing since 2000. Approximately 9,811 miles of main were reported in 2022

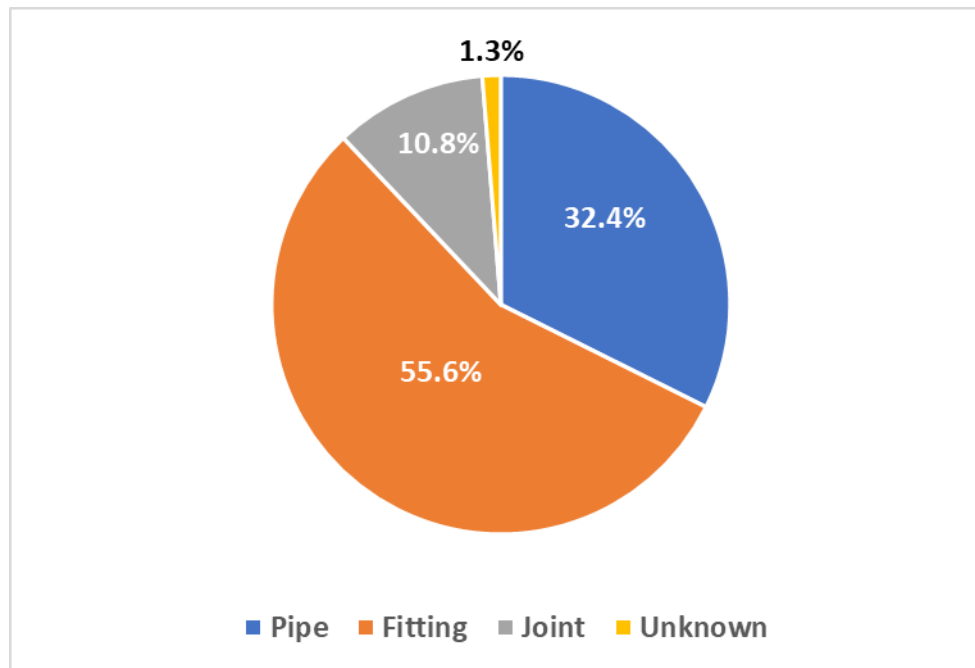
DuPont & Uponor, Aldyl A

DuPont and Uponor, Aldyl A, piping is not identified as separate from other types of polyethylene in the PHMSA Annual Report information. However, the PPDC includes DuPont and Uponor as manufacturers – Aldyl A is approximately 25% of the database.
