# **PLASTIC PIPING DATA COLLECTION INITIATIVE STATUS REPORT**

**February-November 2023**

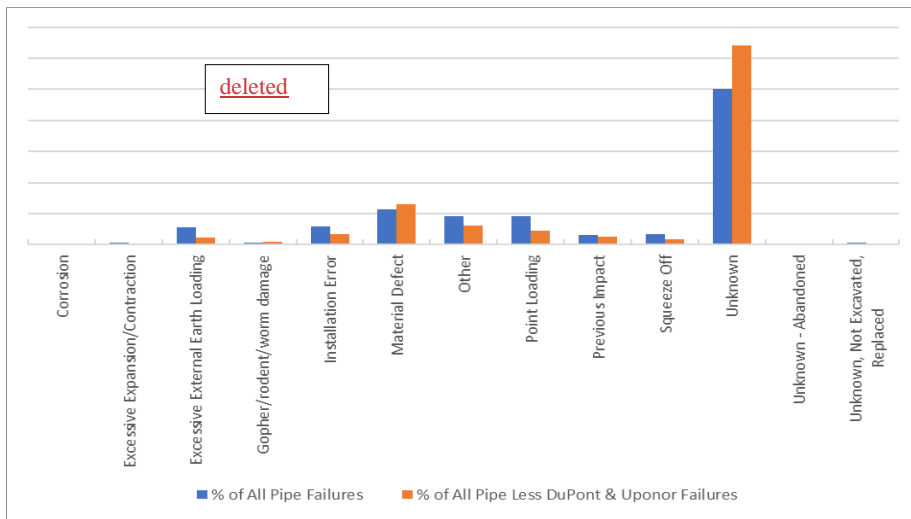
### B32. All Pipe Failures by Material

Note: Percentages less than 0.1% are not listed in the chart

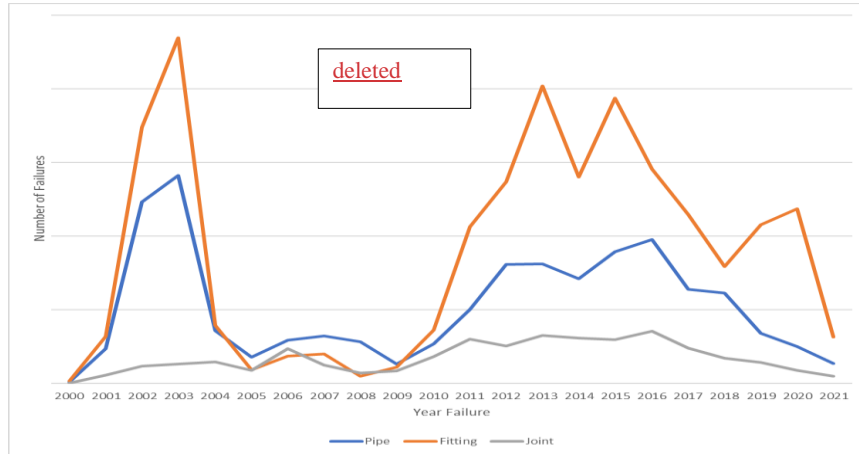
DuPont and Uponor represent approximately ~~2427~~% of all the reports in the database. Figure 1 shows the failures by year of failure. As reflected in the graph, there has been a recent increase in data submitted to the database. The majority of the reported Aldyl failures occur on fittings (56%). Other categories include pipe (32%), joints (11%) and unknown (1%).

**Figure 1. Failures by Year of Failure as reported to PPDC for Aldyl.**

Table 1 reflects an analysis of the three peaks from Figure 1, comparing a change in fitting type failures from 2000-2005, 2010-2015 and 2016-2021. Noting the increase in Cap-type failures, reference Appendix F for more detailed analysis on Caps.

Figure 3 shows the failures by Year Installed. Although Figure 1 shows three data peaks, the year of installation range appears consistent.

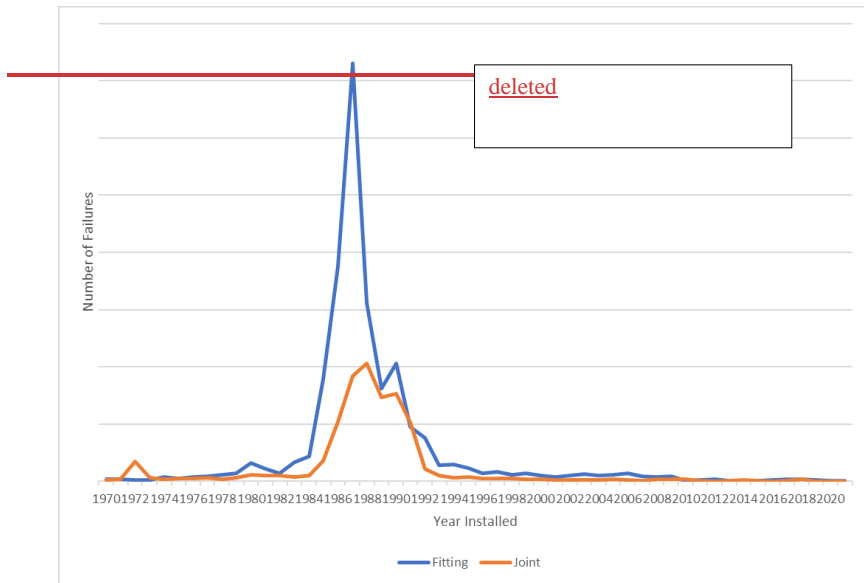
Figure 1 shows Kerotest fittings and joint failures by year installed, which depicts the majority being installed between 1985 and 1992.

**Figure 1. Kerotest Fitting and Joint Failures by Year Installed**
