# **PLASTIC PIPING DATA COLLECTION INITIATIVE STATUS REPORT**

June 2026

## Appendix B: General Failure Data Analysis June 2026

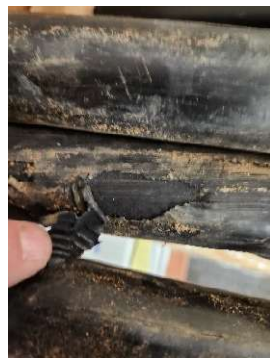
Figure 4

Figures 4 & 5 show external degradation is a peeling effect of the pipe.

**Response from PPDC:** A review of current PPDC data does not correspond with internal degradation processes. The PPDC will continue monitoring data for potential Drisco 8000 internal pipe wall issues with cracking and brittleness and external degradation of peeling of the pipe.
